**MICROSTRUCTURE AND MECHANICAL PROPERTIES OF CRMOV STEEL AFTER LONG-TERM SERVICE**

The paper presents the results of research on the microstructure and mechanical properties of 12HMF steel after long-term service. The investigated material was taken from a pipeline with circumferential welded joint after 419 988 hours of service at the temperature of 490°C, steam pressure 8 MPa. Performed research has shown that the 12HMF steel after service was characterized by a typical microstructure for this grade of steel, that is a ferritic-bainitic microstructure without any visible advanced processes of its degradation. The investigation of mechanical properties has shown that the examined steel after service was characterized by a very low impact energy KV, and yield strength lower than the required minimum. Whilst tensile strength and yield strength determined at elevated temperature was higher and similar to the standard requirements, respectively. It has been proved that the main cause of an increase in brittleness and a decrease in yield strength of the examined steel should be seen in the segregation of phosphorus to grain boundaries and the formation of precipitate free zones near

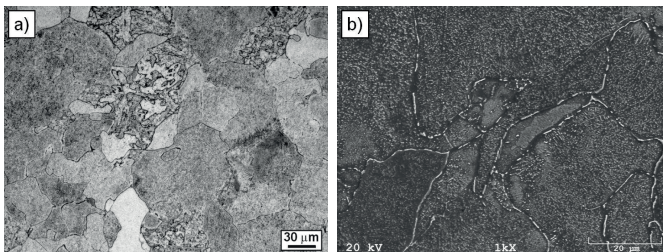
The microstructure of the investigated steel was ferritic–bainitic with the dominant quasipolygonal ferrite amount (Fig. 1). The estimated volume fraction of particular microstructure components was the following: quasipolygonal ferrite – ca. 60%, polygonal ferrite – ca. 30%, bainite – ca. 10%. Quasipolygonal ferrite is ferrite with a large amount of fine dispersive carbides precipitated inside the grains. In the microstructure image with the optical microscopy zoom, this type of ferrite can be seen as grains of grey colour. Quasipolygonal ferrite, at the moment of being formed, has the chemical composition similar to the chemical composition of austenite, out of which it is formed. As a result of carbon supersaturation, during cooling after the austenitization process, and mostly after the following tempering, numerous fine dispersive carbides are precipitated. The colour of polygonal ferrite in the image obtained with optical microscopy is bright. At the forming stage, the chemical composition of ferrite is similar to the equilibrium one, therefore, it does not contain carbides, or it contains some single precipitations [2]. The size of ferrite grain, determined using illustrated models [6], amounted to 5, which corresponds to the mean diameter of grain: 62.5  $\mu\text{m}$ .

Fig. 1. Microstructure of 12HMF steel after long-term service: a) OM; b) SEM

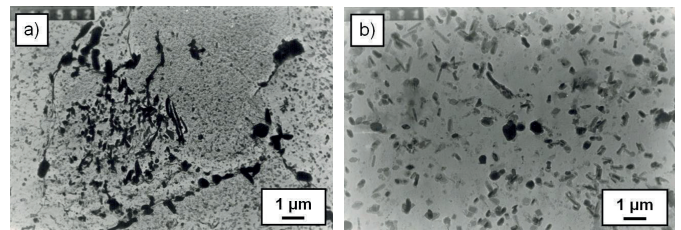
impedes grain gliding against each other, and at the same time contributes to an increase in the microstructure strength, however, at the expense of lowering its ductility. In CrMoV steels in the as-received condition (after the heat treatment), a number of carbides of different thermodynamic stability can be observed ( $M_3C$ ,  $M_2C$ ,  $M_7C_3$ ,  $M_{23}C_6$ , MC). Their type and amount depends on the chemical composition (amount of carbon and carbide-forming elements) and the heat treatment parameters [7-10]. Stability of carbides in the serviced low-alloy CrMoV steels is very high. Researchers have noticed the occurrence of all types of carbides in the serviced steels, even after more than 150 000 hours of work at elevated temperature above 500°C [11-13]. Nevertheless, during the service, not only the enrichment of precipitated carbides with chromium and molybdenum, but also the changes in the morphology and quantitative fraction could be observed. Moreover, during the service of CrMoV steel, precipitation of  $M_6C$  carbides and compound complexes of precipitates, referred to as „H – carbides”, were seen [12, 13]. Performed identifications have shown the occurrence of the following precipitates in the examined steel after service:  $M_3C$ ,  $M_2C$ ,  $M_7C_3$  and MC. Precipitates of  $M_2C$  and MC type were revealed inside quasipolygonal ferrite grains, whilst the  $M_7C_3$  carbides were observed mostly on the boundaries of grains and in bainite. In bainite, also the  $M_3C$  carbides were noticed. Example of the morphology of carbides in the investigated steel is shown in Fig. 2.

Fig. 2. Morphology of carbides in the examined steel: a) in the bainite area and on the grain boundaries, b) inside ferrite grains, carbon extraction replica, TEM

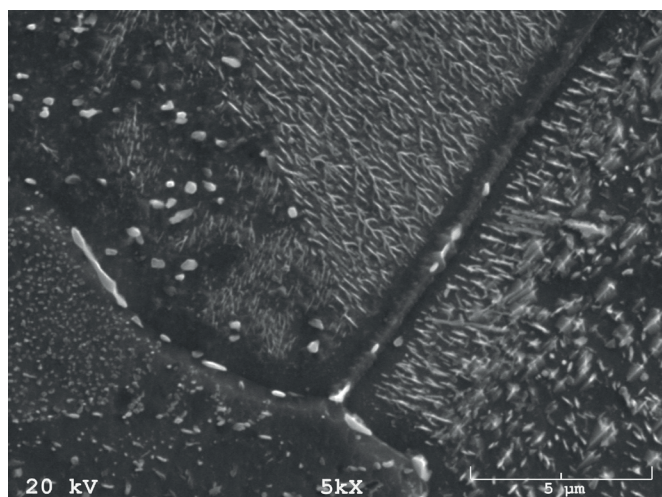
Fig. 3. Precipitate free zone near the boundaries of ferrite grains

According to researchers [2, 15, 16], the formation of these zones is connected with the processes of precipitation and growth of carbides on the boundaries of grains, and the width of this zone is dependent on both: the service parameters and chemical composition of the steel [2, 16]. The depletion of precipitates in these areas near the grain boundaries decreases the strength of these areas and constitutes a deciding factor responsible for the slowly progressing decline of strength properties throughout the service time.

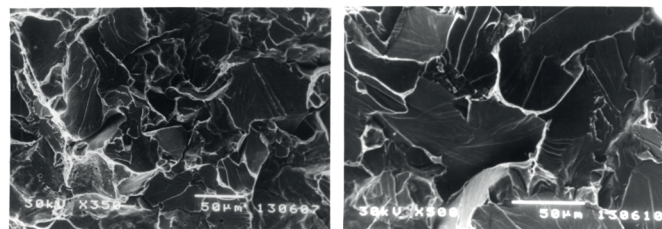
The studies of mechanical properties have shown that the CrMoV steel after service was characterized by very low impact energy KV, which was over five times as low, compared to the required minimum of 27 J (Table II). Performed fractographic tests have proved that the examined steel was cracking with the brittle transcrystalline cleavable mechanism (Fig. 4). Moreover, on the fracture, numerous secondary cracks were observed. They ran on the boundaries of grains. The presence of intergranular secondary cracks proves the brittleness and softening of the boundaries.

Fig. 4. Fractography of the fracture in the examined steel
