THE PHENOMENON OF HYDROGEN EMBRITTLEMENT IN HIGH-STRENGTH BOLTS

Keywords: cold forging; hydrogen embrittlement; high-strength bolts

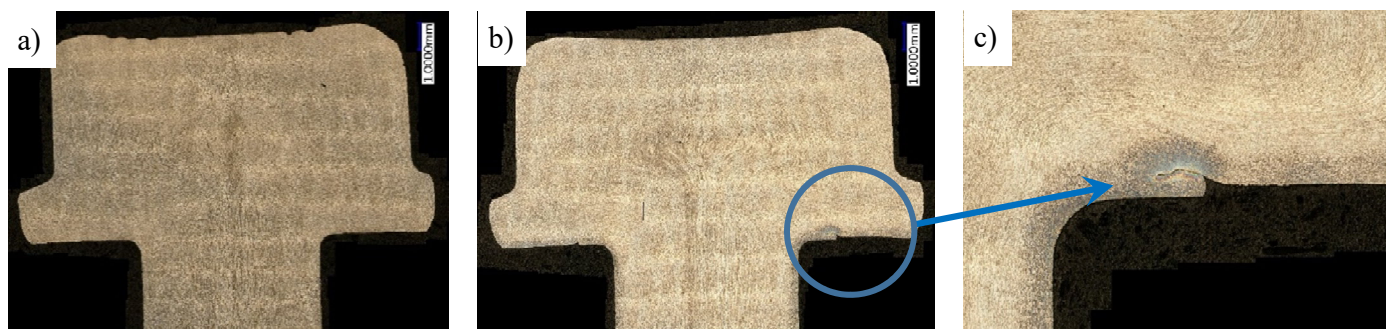
The variations of the samples differed by the change of the constant volume principle for one of them, and thus by the change of the pattern of the fiber arrangement in the part of the bolt head (Fig. 1). In one variant, in the first forging operation, the material was upset from a too small part of the volume of the prepared wire semi-product. More material was left in the bolt pin. As a consequence, in the following operations, the bolt material was forced into the bolt head, leading to the phenomenon of lap forging on the bearing surface of the bolt flange (Fig. 1c).

Fig. 1. Samples of polished longitudinal sections of DIN 6921 M6x20 bolts after the forging process with the grain flow pattern. a) variant compatible with the technology used, b) variant with a deliberate defect of lap forging the bearing surface, c) the lap forging of the bearing surface

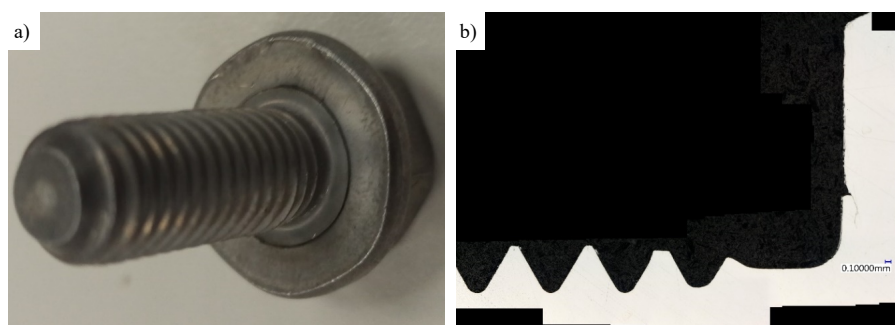
to cracks. The bolt threads, the first thread (thread starting from the bolt pin with a larger radius at the bottom than the rest of the thread) and the radius between the bearing surface and the pin were checked. In samples 1 and 3, no additional cracks were found, apart from the lap forging defects generated intentionally in the forging process (Fig. 6). Longitudinal sections of the bolts for metallographic evaluation were prepared. The analysis showed no new crack nuclei. The lap forging length of the bolt was measured and compared with the samples immediately after the forging process (Fig. 7). The measurement was to show whether the lap forging defect propagated, the end of which can be defined as a notch during the HE test. There was no significant increase in the length of the defect. The difference obtained in favor of the samples after the test could have resulted from

Fig. 6. Evaluation of sample 1 of variant 1 after the test. a) assessment of surface discontinuities, b) assessment of the bolt longitudinal section

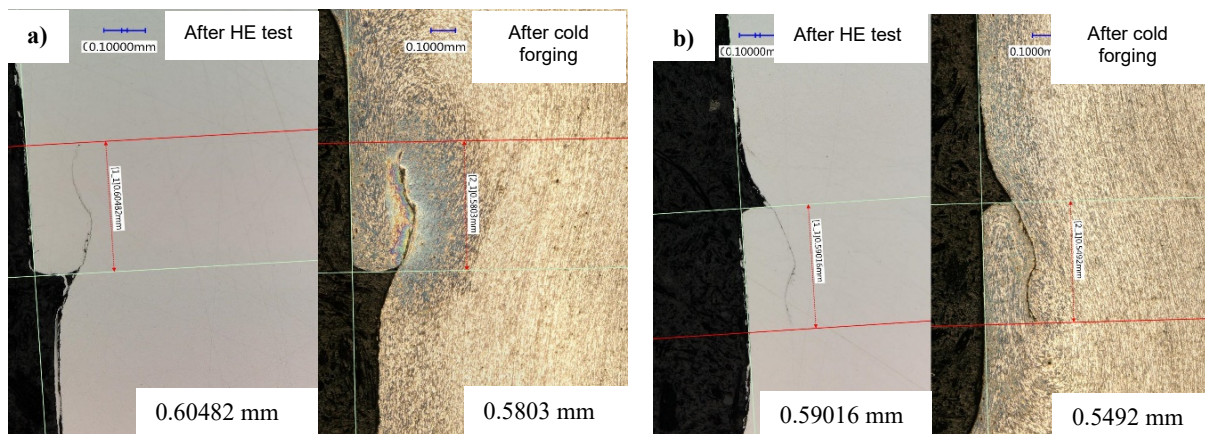
chance and depended on the variability of the forging process, high strain rates, tool heating, and production speed reaching 180 pcs/min. In the future, for the remaining samples prepared for HE tests, it is planned to extend the test to 200 hours to assess the potential increase in the length of the lap forging defect due to the diffusion action of hydrogen atoms.

Fig. 7. List of the clamping length for the bolt after the HE test and after the forging process (before heat treatment), a) right side of the bolt, b) left side of the bolt

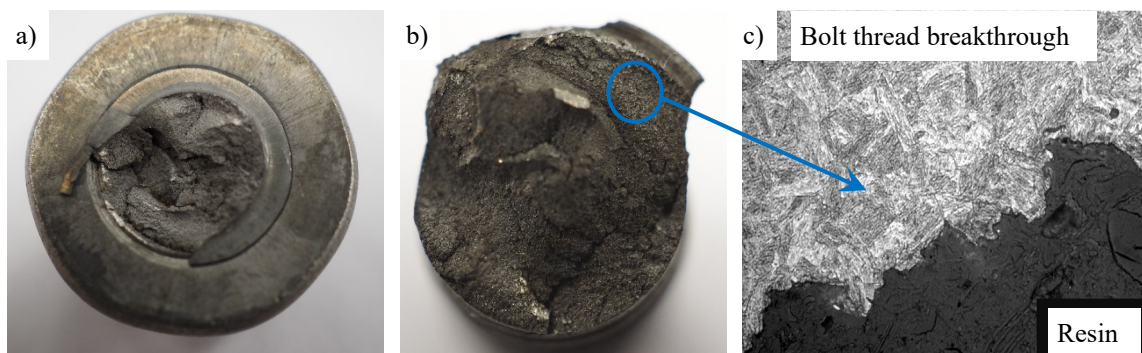
A breakthrough was made in sample 2 of variant one (Fig. 8). Macroscopic and microscopic analysis allowed us to classify the type of scrap as brittle. The crack after evaluating the polished sample of the bolt thread was defined as an intercrystalline crack. There are no places where plastic scrap occurs, this is due to the fact that the tension in the bolt dropped after the crack had occurred. The clamping force was reduced by increasing the clamping length on the bolt due to a break.

Fig. 8. Assessment of breakthrough of the bolt after failure, a) bolt head, b) threaded bolt pin, c) cross cut from the threaded bolt pin

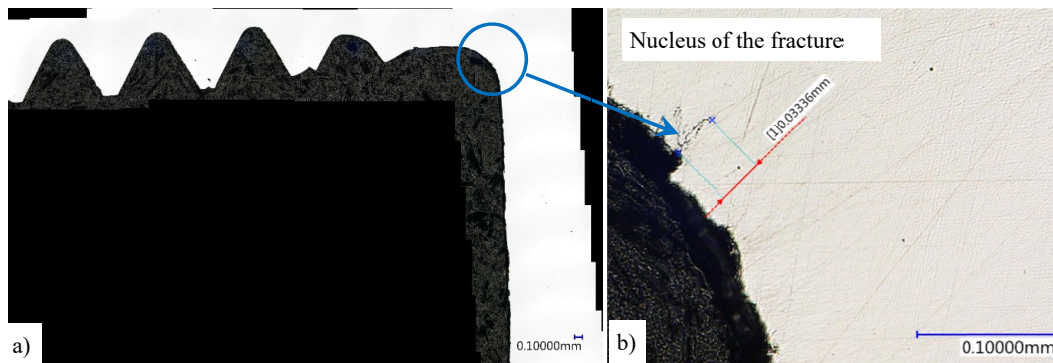
exposed to the wedge, of increased tensile stress. The nucleus of the crack was located in the radius between the bearing surface and the bolt pin. The stress point in the loaded bolt. The first microscopic assessment did not give a clear answer as to whether the image shows a crack germ, there was a risk of confusion with a defect in the sample polishing process. The sample was polished again, which confirmed the presence of a defect in the same place. The length of the crack nucleus (Fig. 9b) is 0.03336 mm, it was created as a result of a notch on the surface. The notch could have resulted from the random sticking of semi-product material particles to the die.

Fig. 9. Microscopic evaluation of a polished longitudinal sample, a) evaluation of surface discontinuities in places exposed to cracking, and b) crack nucleus on the radius
