A. ZIELIŃSKI\*<sup>‡</sup>, G. GOLĄŃSKI\*\*

## THE INFLUENCE OF REPAIR WELDED JOINT ON THE LIFE OF STEAM PIPELINE MADE OF Cr-Mo STEEL SERVICED BEYOND THE CALCULATED WORKING TIME

*Keywords:* creeping, material diagnostics, welded joints after service, Cr-Mo steel, residual life

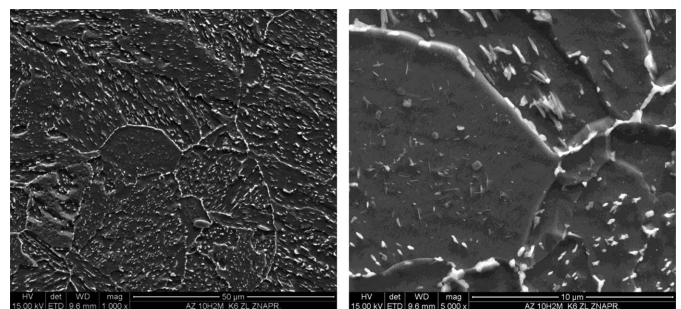
Figure 2 presents an example of the microstructure of the base material after service. After long-term service, the base material was characterized by a ferritic – bainitic microstructure. The dominant phase in the microstructure of the investigated steel was quasipolygonal ferrite with very fine numerous precipitates evenly distributed inside the grains. In bainitic areas, a considerable number of carbides of diverse size was observed, with a visible progressive coagulation process. On the boundaries of ferrite grains, there were precipitates of diverse size observed, forming “a continuous grid of precipitates” in some areas.

Fig. 2. Microstructure of base material after service

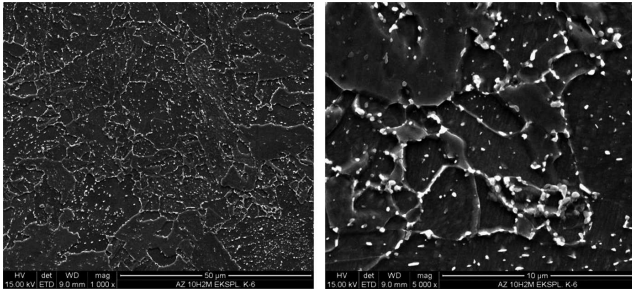
In the heat-affected zone (Fig. 3) of the joints after service, a microstructure consisting of ferrite with numerous precipitates of diverse size and shape close to spherical were observed, arranged inside the grains and on the grain boundaries. The precipitates located on the grain boundaries, similarly as in the base material (Fig. 2), in some areas, formed the so-called “continuous grid of precipitates”. Highly advanced process of degradation of this area of joint is mostly connected with the influence of welding process and heat treatment after welding on the changes in microstructure, and depends on the service to a smaller extent.

Fig. 3. Microstructure of heat-affected zone of welded joint after service

Advanced degradation of this area compared with the base material, among other things through the processes of polygonization of the matrix, and the precipitation and coagulation of  $M_6C$  carbides [14] can contribute to the formation of a joint of the so-called IV-type cracks in this area.

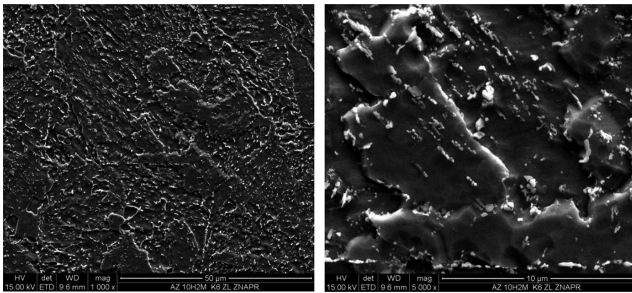
The microstructure of heat-affected zone (Fig. 4) of the repair joint was a ferritic – bainitic microstructure with numerous carbides of dominant lamellar shape.

Fig. 4. Microstructure of heat-affected zone of welded joint after repair

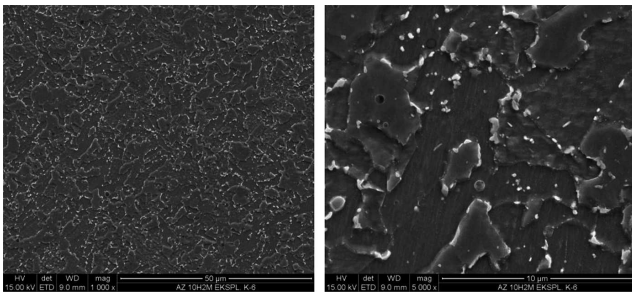
Fig. 5. Microstructure of weld seam of welded joint after service

The observed microstructures in the welded joint after long-term service (Fig. 5) and after repair (Fig. 6) were similar. In the bainitic microstructure of the weld seam after service (Fig. 5), however, more advanced precipitation processes were visible.

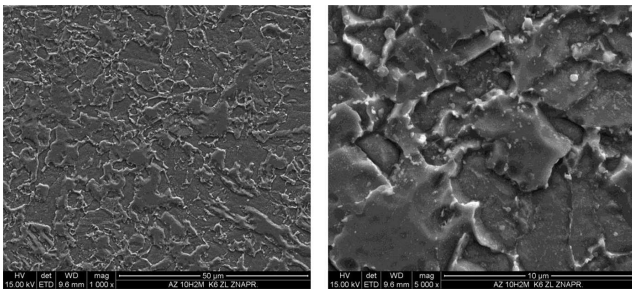
Fig. 6. Microstructure of weld seam of welded joint after repair

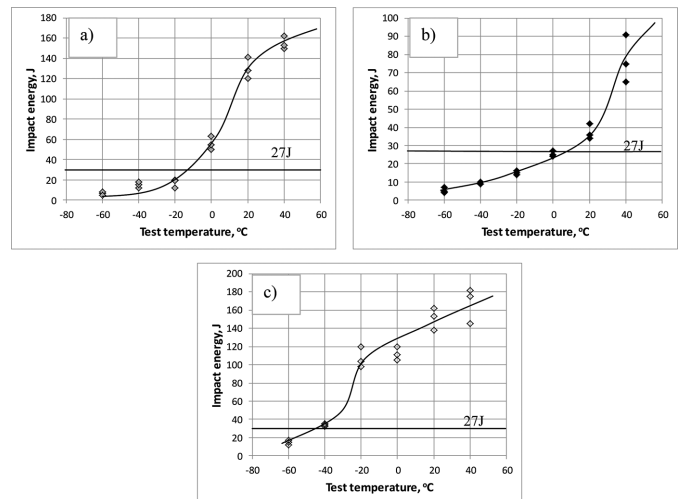
Fig. 7. Determined nil ductility transition temperature for: a) base material, b) material of weld seam after service, c) material of repair weld seam

towards higher temperature. The nil ductility transition temperature determined for the investigated materials, that is the base material, welded joint, and repair joint, amounted respectively to:  $-15^{\circ}\text{C}$ ,  $+10^{\circ}\text{C}$ , and  $-40^{\circ}\text{C}$  (Fig. 7). The low nil ductility transition temperature of the base material indicates a slight degree of degradation of the steel microstructure.

Higher impact strength and lower transition temperature of the repair joint in comparison with the joint after service probably results from the less advanced precipitation processes (Fig. 5, 6). Positive temperature of transition of the weld seam material of the welded joint after service puts an absolute obligation of fulfilling the required conditions when starting up and shutting down the boiler.

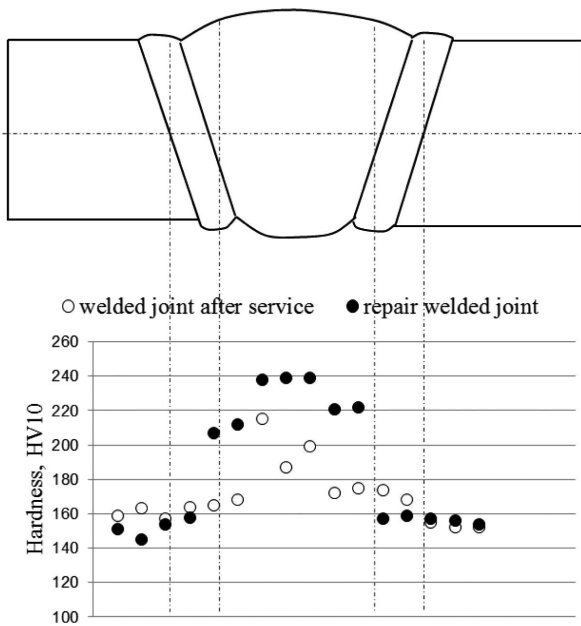
The measurement of hardness of elements of welded joint after service did not show any rapid changes at the transition through particular joint zones, unlike the elements of repair joint (Fig. 8). Hardness in particular zones of the joint after service differs by the maximum of around 55 units and does not exceed 220 HV10. Whereas hardness of the repair welded joint does not exceed the acceptable value of 350 HV10 and ranges from around 150 HV10 in the areas of base material to around 240 HV10 in the weld seam.

Fig. 8. Distribution of hardness on cross section of welded joint after service and repair welded joint

A lighter course of changes in hardness on the cross section of the joint after service compared with the repair joint probably results from the changes running in the microstructure of this area during long-term service.

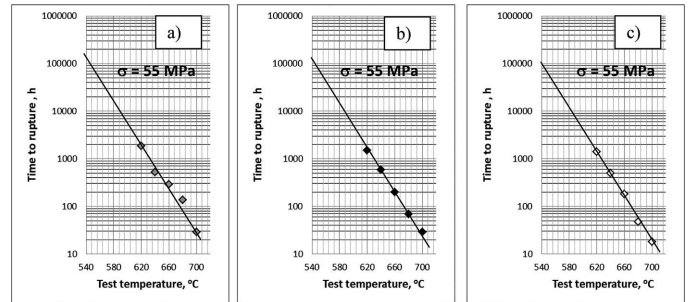
The results of short-time creep strength of the base material, the joint after service, and the repair joint are presented in Fig. 9.

Fig. 9. Creep-rupture strength of: a) base material, b) material of weld seam after service, c) material of repair weld seam

The base material was characterized by the bigger disposable residual life (90 000 h). Whereas the life of the repair welded joint (60 000 h) was lower than the disposable life of the joint after service (72 000 h) by 18%.
