A.C. BERBECARU¹, G. COMAN¹, S. CIUCĂ¹, I.A. GHERGHESCU^{1*},
M.G. SOHACIU¹, C. GRĂDINARU¹, C. PREDESCU^{1*}

RESEARCH ON THE DEGRADATION PROCESS OF RAILWAY RAILS DUE TO LIFESPAN EXCEEDING

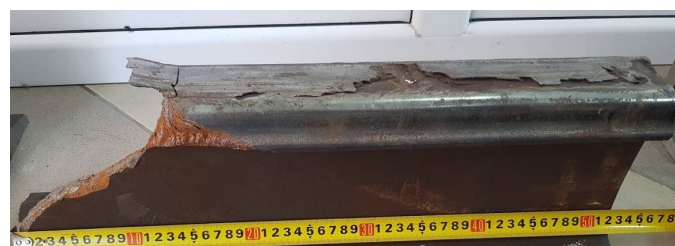
The present research aimed to determine the causes that led to the degradation of the railway tracks as a result of exceeding their lifespan, which led to the occurrence of a railway accident. The investigated material was a line rail coupon in the breaking area that showed numerous defects of the contact surface. Figure 1 shows the aspect of this tested and analyzed sample.

Fig. 1. Coupon aspect in the fracture zone

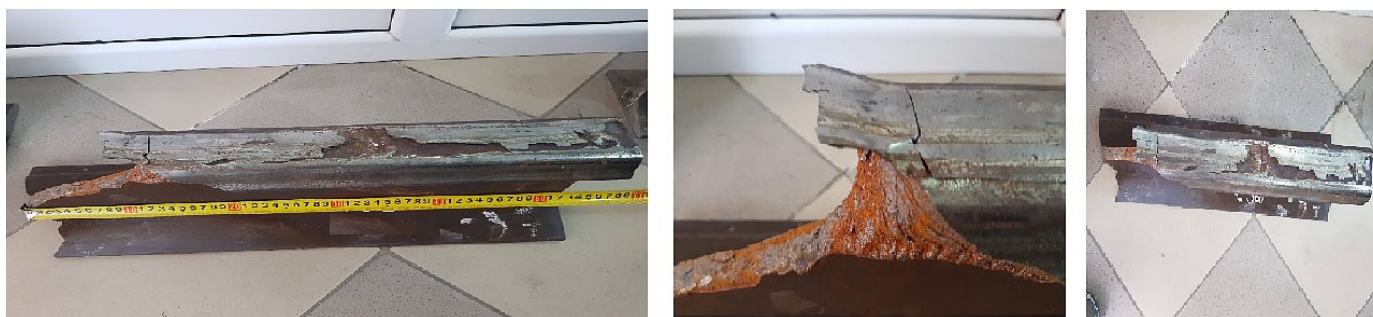
The macroscopic analysis of fracture surfaces suggests a classic type of rolling contact fatigue fracture under alternating cycles.

Thus, in the upper part of the line rail (rail head), several microcracks appear which, under stress, are propagating slowly and intermittently. In that region, the appearance of the surfaces separated by the crack has a smooth character, which shows that the fracture was advancing through the ductile mechanism. Once the effective section has been exceeded, the rupture progresses rapidly, according to the fragile mechanism. The advancing direction is uncontrolled, exhibiting a jag or spaced faults feature, quickly traversing the rail web and ending in the rail base. The feature in these areas is grained, rough, specific to fragile rapid rupture. Considering our line rail coupon and evaluating the surface quality of the rail head in longitudinal plan but also from a side view, its advanced wear is very clearly highlighted.

Fig. 2. Aspect of macroscopically analyzed areas and fracture surfaces

The crack initiation and propagation processes resulting from a mechanical loading have been widely studied [5-9]. Thermally damaged surface layers, called white etching layers (WELs), also contribute to crack initiation [10-13]. Cracks nucleating in or close to WELs can develop into so-called squats and studs on the rail head [4], leading to delaminations, which are numerous on our studied coupon.

There are many areas where the metallic material shows cracks, damaged surface layers and severe delaminations. From the side view one may see the specific gauge corner (fillet) zones being very asymmetrical, with different fillet radii and uneven opening angles that suggest advanced wear.

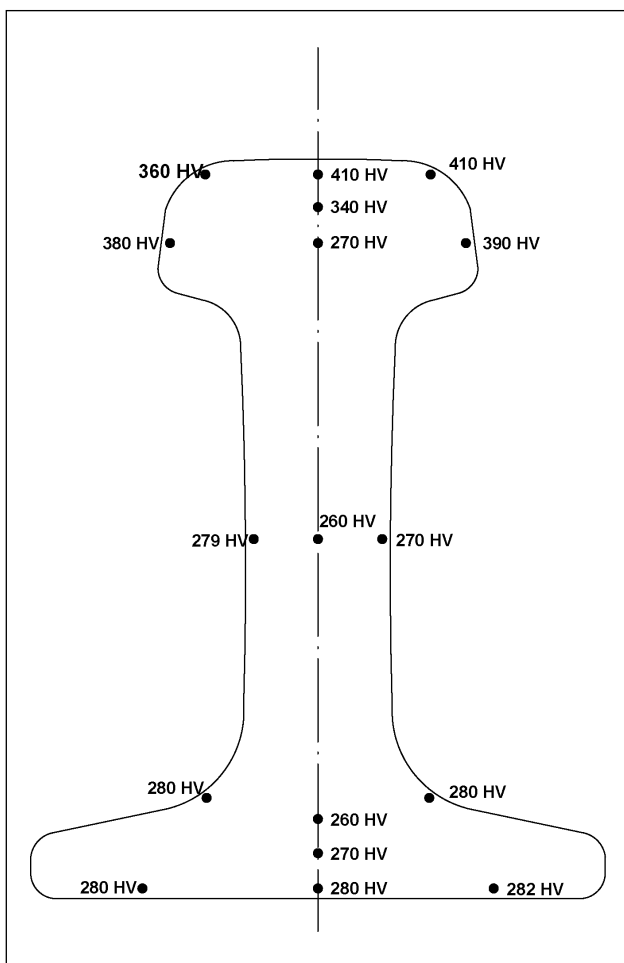
Fig. 3. Vickers hardness values distribution on the line rail sample cross-section

- RAIL HEAD – in the upper part one can find higher values (360-410 HV) that lower down to a stable value of 270 HV in its core zone;
- RAIL WEB – the average hardness values are of approximately 270 HV;
- RAIL BASE – the average hardness values are of approximately 280 HV; these average values of approximately 270 HV are characteristic for the equilibrium structure of a slightly hypereutectoid, light alloyed steel, such as the line rail that is under investigation.

The hardness values recorded on the top of the rail head and on the gauge corner and symmetrical zone (fillet zones) suggest the modification of the structure over time by surface hardening phenomena, meaning a *strain hardening*, phenomenon consisting in a hardening under load. It is also known as *work (cold) hardening*: in a steel structure submitted to a load, the ferrite flattens and the cementite lamellae fragment, becoming preferentially oriented along with the ferrite crystals (or lamellae), respectively perpendicular to the load direction. It is the stress type the line rails are usually submitted to in service.

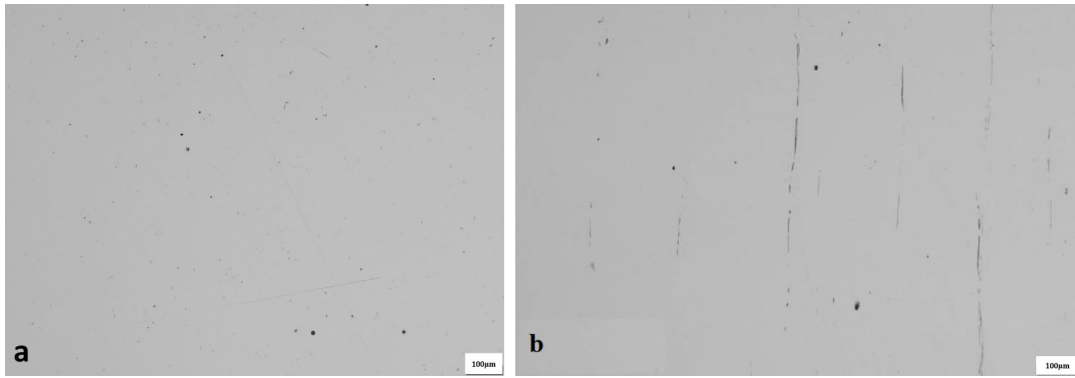
The highlighted inclusion state is considered to be a correct one, according to the steel chemical composition determined by optical emission spectrometry. The analysis was performed both in longitudinal section and in cross section at $\times 100$ magnification, according to the specialized standard. Very relevant are the examinations performed in longitudinal section. Thus, one

Fig. 4. Optical micrographs of the unetched samples: a) cross-section, b) longitudinal section, 100×

can observe either dispersed, crushed inclusions with angular edges, considered to be alumino-silicates resulted from specific deoxidation reactions taking place along the smelting process, or continuous, elongated inclusions identified as plastic inclusions of MnS, also forming on smelting from desulfurization reactions. All inclusions, without exception, show a preferential orientation being aligned along the hot rolling stress direction, the deformation process being part of the line rails manufacture technology.

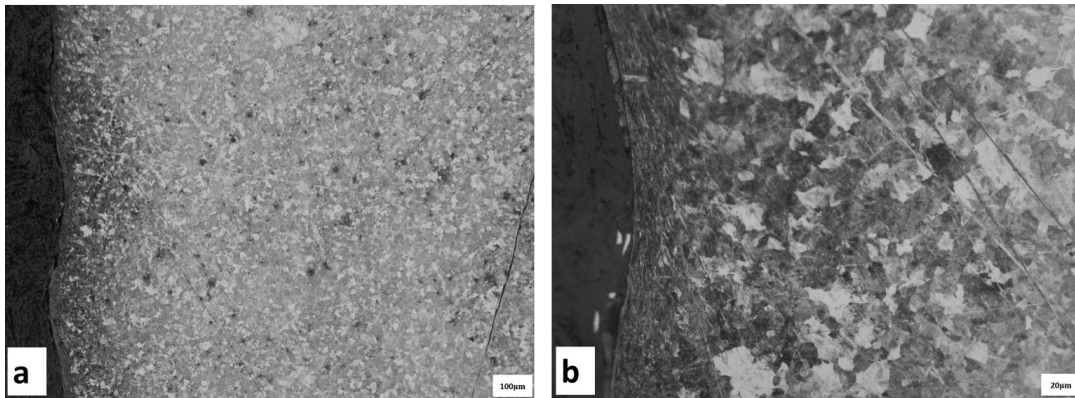
In Figure 5(a), the microstructure recorded in the superficial area a very thin layer on the line rail head.

Figure 5(b) reveals better the superficial layer, having a depth of 20-40 µm and a rather fine needle – like feature, that is, in fact, deformed pearlite. Consequently to a very long time load application, perpendicular to the top of the rail head, the ferrite lamellae flatten, the cementite lamellae shatter, becoming preferentially oriented along the thinned ferrite lamellae, also perpendicular to the load application direction. The structure

Fig. 5. Optical micrographs of the line rail head, reagent Nital 2%, a) 100×, b) 500×

One may also notice in Figure 5 an irregular profile of the rail head exterior side and fillet, suggestive of an advanced wear process that took place in a long operating time of the line rail.

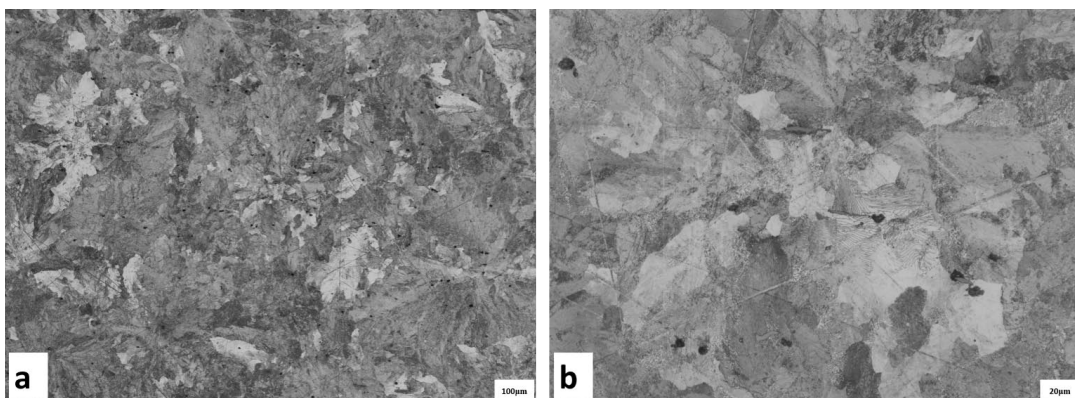
Fig. 6. Optical micrographs of the line rail web, reagent Nital 2%, a) 100×, b) 500×

The structures corresponding to the rail web and rail base zones (Fig. 6 and Fig. 7) are lamellar perlite equilibrium structures, expected to be found in a steel with this chemical composition.

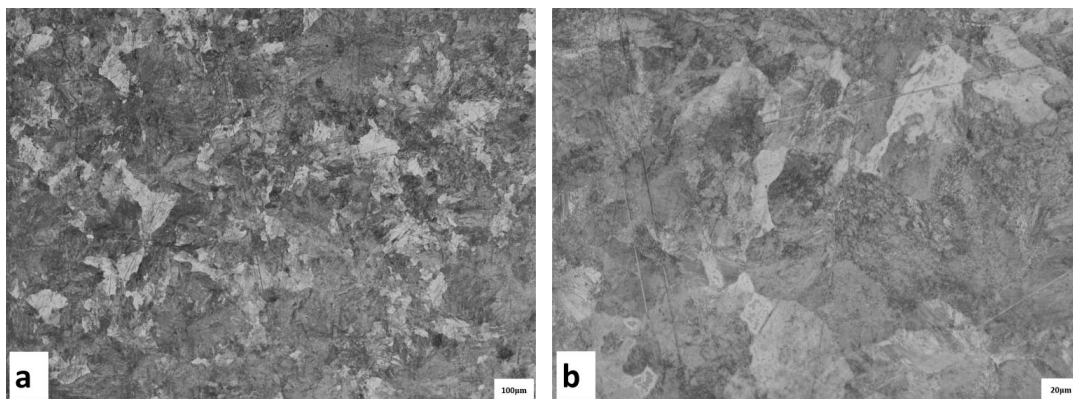
Fig. 7. Optical micrographs of the line rail base, reagent Nital 2%, a) 100×, b) 500×

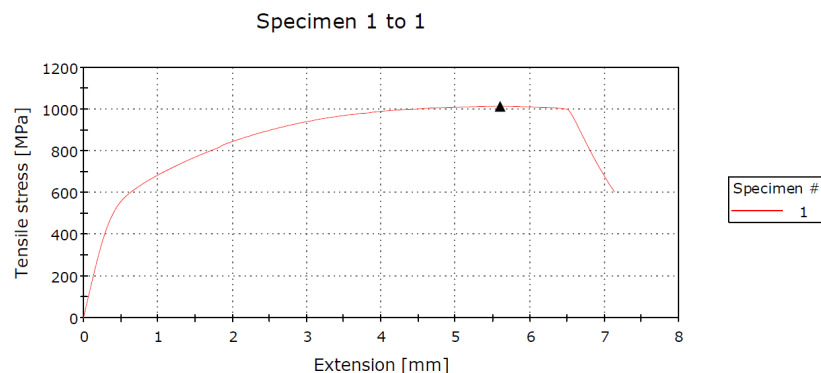
Figure 8 shows the stress-strain curve obtained by tensile testing as well as values of ultimate tensile strength (1014 MPa), elongation at break ($A = 13\%$), striction ($Z = 19\%$).

Besides these values, one can easily read on the diagram that the yield strength is approximately 500 MPa.

According to the SR EN 13674-1 norm, the R260 steel grade must have the following mechanical characteristics values: $R_m = \text{min. } 880 \text{ MPa}$; $A = \text{min } 10\%$; $HBW = 260\text{-}300$, on the longitudinal axis.

Fig. 8. Stress-strain curve obtained by tensile testing, values of yield strength and ultimate tensile strength, elongation at break ($A\%$), striction ($Z\%$)
