## THE ASSESSMENT OF THE COLD PLASTIC WORKABILITY OF 20MnB4 STEEL WIRE ROD

The paper presents the results of cold upsetting testing of 16.5 mm-diameter 20MnB4 steel wire rod. The main purpose of the study was to evaluate the ability of wire rod produced in industrial conditions for further cold metal forming. Due to the fact that cracks occurred in the test material at different strain values, the authors made an attempt to answer the question whether there are any crack initiators in the material structure, or the observed cracks are due to the manufacturing process parameters.

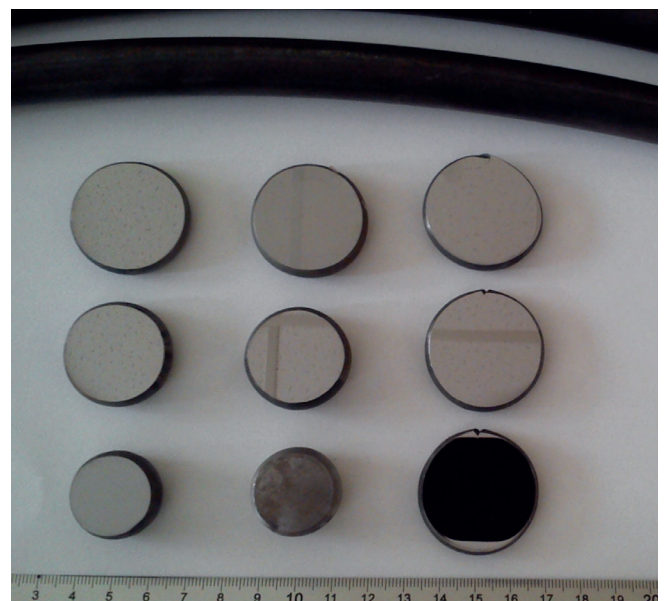
A general view of wire rod of the steel grade under investigation and microsections are shown in Fig. 1.

Fig. 1. 16.5 mm-diameter 20MnB4 steel wire rod and test specimen microsections
