**OPERATION-ORIENTED STUDIES ON WEAR PROPERTIES OF SURFACE-HARDENED ALLOY CAST STEELS USED  
IN MINING IN THE CONDITIONS OF THE COMBINED ACTION OF DYNAMIC FORCES  
AND AN ABRASIVE MATERIAL**

This paper presents the results of wear tests of shot-peened and not shot-peened cast steels used in the mining machinery industry, in particular in the construction of chain drums for armoured face conveyors. Wear tests were carried out in the conditions corresponding to the real operating conditions of armoured face conveyors during drifting work in rocks such as sandstone. The operating factors subjected to the analyses included the presence of quartz abrasive and the impact of external dynamic forces. On the basis of the wear tests as well as the microhardness and microstructure examinations performed, it has been found that the action of an additional dynamic force has a synergistic impact on the process of abrasive wear in loose quartz abrasive. It has been further found that the value of abrasive wear of chain wheels operated in the conditions of a combined action of abrasive and a dynamic force depends on whether the area of mating of wheels with the chain was shot-peened or not before

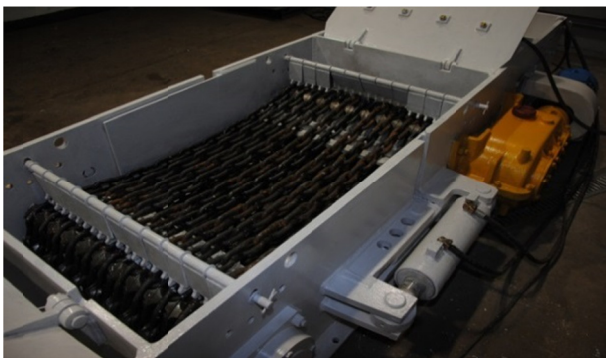
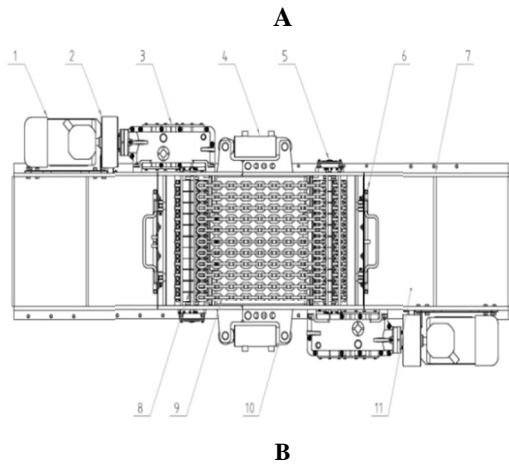
Fig. 1. Test rig, A. View B. Diagram; designations: 1 – Induction motor 22 kW, 2 – Flexible coupling, 3 – Conical-cylindrical reduction gear, 4 – Hydraulic cylinder, 5 – Axle shaft, 6 – Sprinkler system for the test chamber, 7 – Body of the test rig, 8 – Test samples, 9 – Chain, 10 – Mounting bracket of the hydraulic cylinder, 11 – Additional chamber for aggregate

A view and a diagram of the test rig used in the wear tests are shown in Fig. 1. A diagram of the load of the chain wheels for the abrasive wear test is shown in Fig. 2A, while for the abrasive-dynamic test – in Fig. 2B.

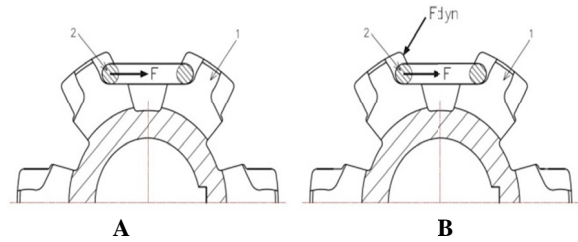
Fig. 2. Diagram of the load of a drum chain; A – for variant 1 of the wear test, B – diagram of the load of the chain drum for variant 1 of the wear test; designations: 1 – chain wheel, 2 – chain, F – driving force, F<sub>dyn</sub> – external dynamic force obtained by the use of beaters

The design of the test rig enabled filling of the test box with any abrasive mixture as well as inducing an external force. Beaters with the mass of 1 kg were installed in the test rig in such a way that each tooth of the chain wheel was hit during the rotation of the drive shaft.

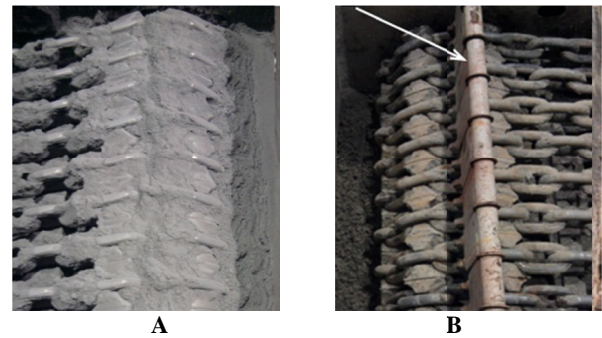
Fig. 3. Test rig, A – a view of the test chamber of the test rig during the wear tests with dry quartz abrasive (variant 1), B – a view of the test chamber of the test rig during the wear tests with dry quartz abrasive and a dynamic load (variant 2); the arrow indicates the installed beaters

Fig. 3A presents a view of the test chamber of the test rig during the wear tests in the presence of quartz abrasive, while Fig. 3B shows a view of the chamber with installed beaters for the wear test with a dynamic load (abrasive-dynamic test).

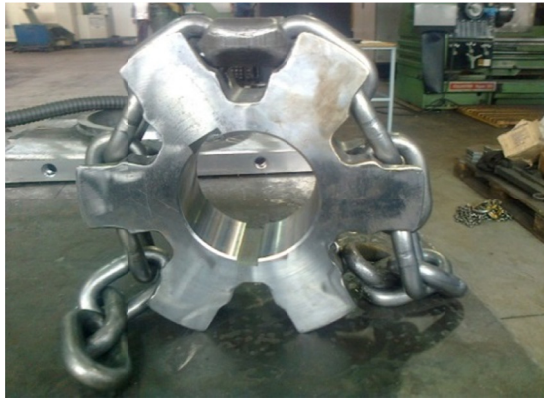
Fig. 4. Test chain wheels

The object of tests were chain wheels (Fig. 3) made of alloy cast steels: GS42CrMo-4, L35GSM, L30GS, 20HGSNM and A6.

The test chain wheels were cast in sand moulds and subjected to normalization as well as quenching and tempering. After the final machining, the chain wheels were subjected to surface hardening. The surface hardening was performed using the flame method; the surfaces subjected to machining were heated to a temperature of approx. 800°C, and then cooled in 6% solution of water-polymer coolant.

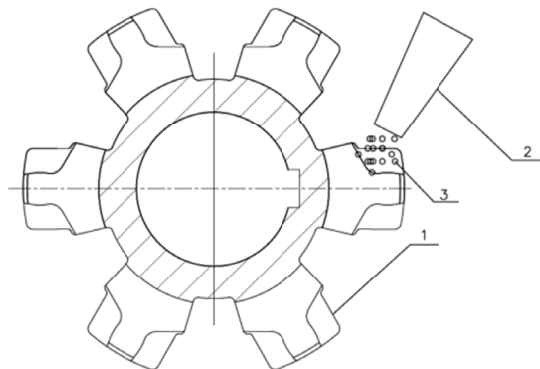
Fig. 5. Diagram of the process of shot peening of chain wheels; 1 – area of mating of the chain drum, 2 – nozzle of the shot-peening machine, 3 – shot

Two identical sets of chain wheels were used for the wear tests. One of them was subjected to shot peening. The shot-peened chain wheels in the area of the contact between the wheel and the chain (Fig. 4) were subjected to a dynamic treatment with the Almen intensity of 0.32% mmA and the coverage of 2×100%. Shot peening was conducted with the use of cut and rounded shot with the diameter of 0.6 mm and the hardness of approx. 54 HRC. Sample views of the surface subjected to shot peening, obtained on the basis of observations with the use of HITACHI S-3500N scanning electron microscope, are shown in Fig. 5. As a result of the action of shot on the tooth surface, there were formed flat deformations with distinct borders of the areas deformed (Fig. 6A) and cracks appeared in the surface layer (Fig. 6B).

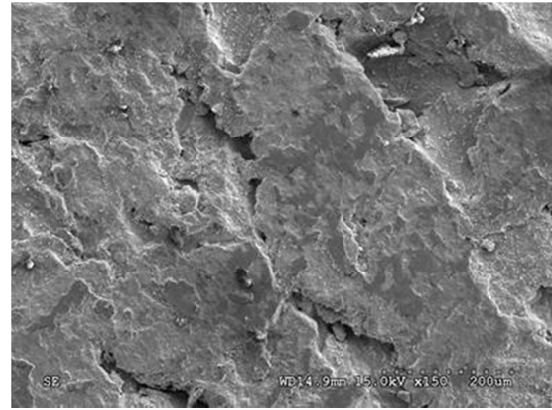
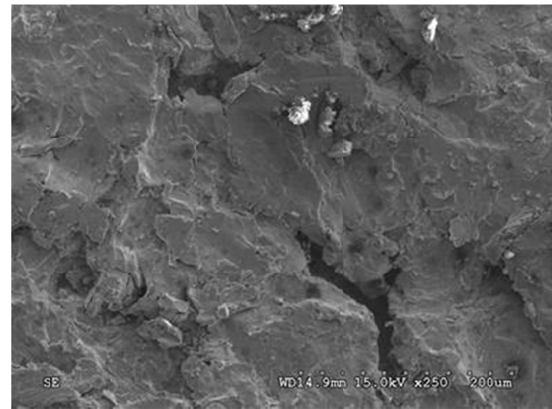
Fig. 6. Deformations of the surface of the chain wheels made of GS42Cr-Mo4 cast steel caused by the action of shot; A – flat deformations with distinct borders of the areas deformed, B – cracks in the surface layer

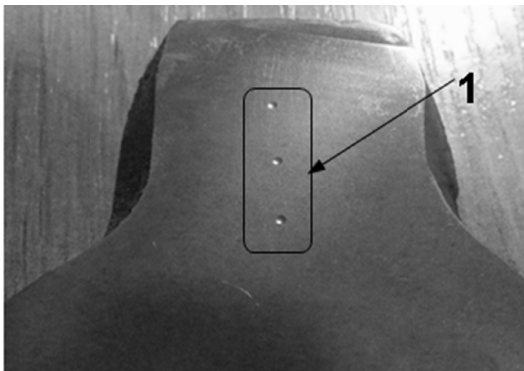
Fig. 7. A view of the area (1) of the tooth subjected to Brinell hardness test

Metallographic tests and measurements of hardness were carried out after the wear tests. Hardness was determined with the use of the Brinell HB method on hardened surfaces of the side teeth (Fig. 7). The structure was determined by cutting out

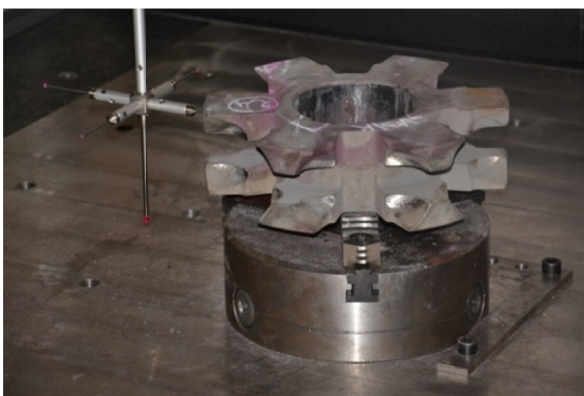
Fig. 8. A view of a chain wheel during the measurements on the coordinate measuring machine

In order to determine the abrasive wear of the chain wheels, the areas of mating between the chain wheel and the chain were measured before and after the wear test using a coordinate measuring machine (Fig. 8). The area of mating between the wheel and the chain was represented by at least 300 points making up the route of the measuring head of the machine (Fig. 9).

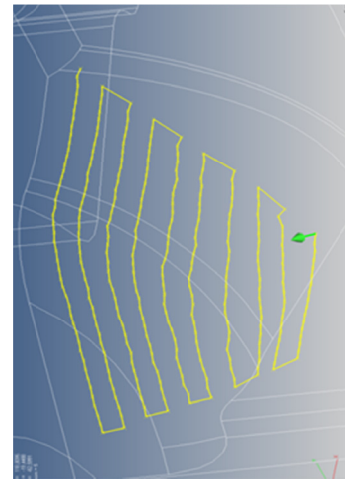
Fig. 9. A view of the route of the measuring head superimposed on the model of the chain wheel (the arrow indicates the end point of the route of the measuring head)

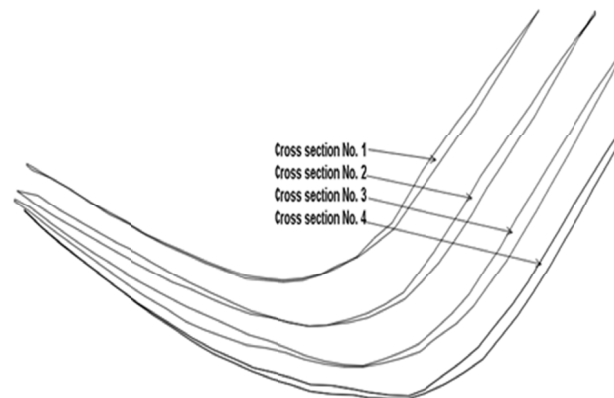
Fig. 10. A view of the surfaces obtained using the data from the measurement of the surface of a tooth made of GS42CrNiMo4 cast steel, before and after the wear test

teeth of the chain drum. Fig. 10 shows the effect of merging the first 4 lines of the route of the measuring head determined before and after the wear tests. It can be easily seen that these paths merge, giving as a result a surface with a variable height, on the basis of which the measures characterising the abrasive wear of the chain wheels can be determined.

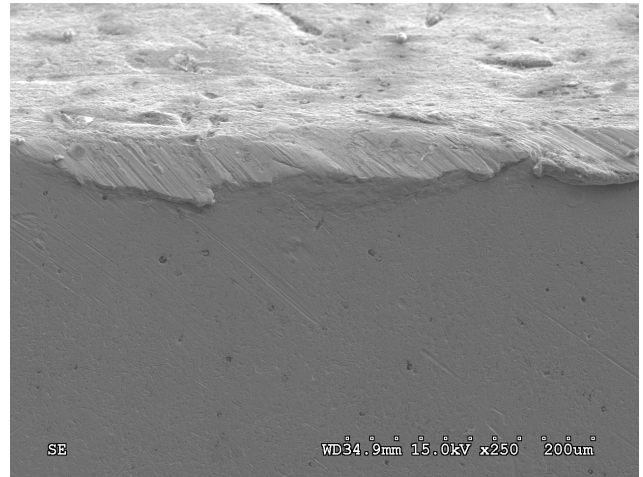
Fig. 11. Traces of microcutting by grains of quartz abrasive on the surface of a wheel made of L35GSM steel

The basic mechanism of destruction of the wheel surfaces mating with the link chain in the presence of quartz abrasive was the process of microcutting. The effects of the cutting action of quartz grains are illustrated in Fig. 11. Large cuts caused by the action of the abrasive can be easily seen in the material of the chain wheel.

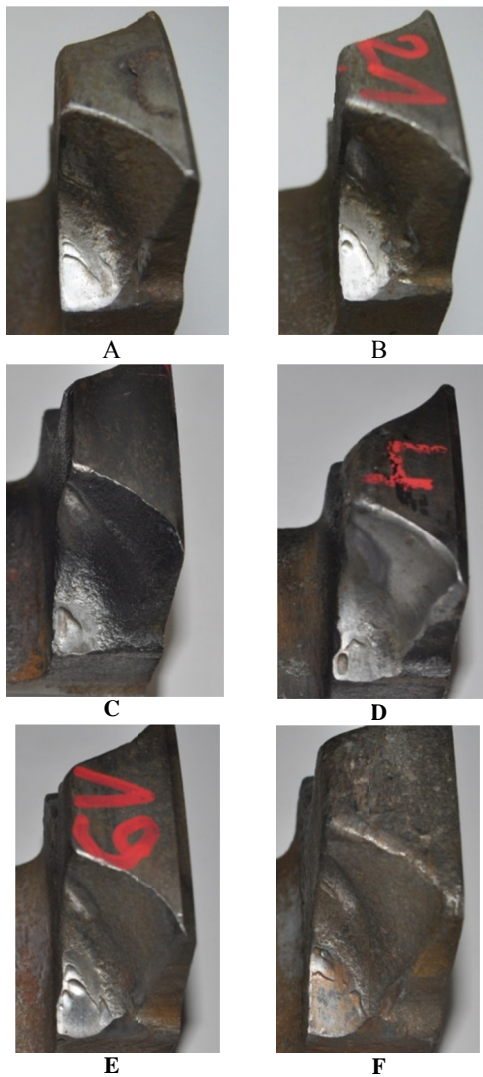
Fig. 12. A view of the area of mating between the cast steel wheels and the chain; A – L35GSM, B – L20HGSNM, C – GS42CrMo4, D – L30GS, E – GS42CrMo4\_SP, F – A6

- flat abrasions in the area of mating with distinct border between the zone subjected to the wear and the zone not subjected to the wear (Fig. 12A); small single cavities may occur in the area of abrasion (Fig. 12B),
- deep abrasions in the area of mating having a lenticular shape (Fig. 12C and 12D),
- abrasions in the area of mating with noticeable fairly deep cracks (Fig. 12E and 12F).

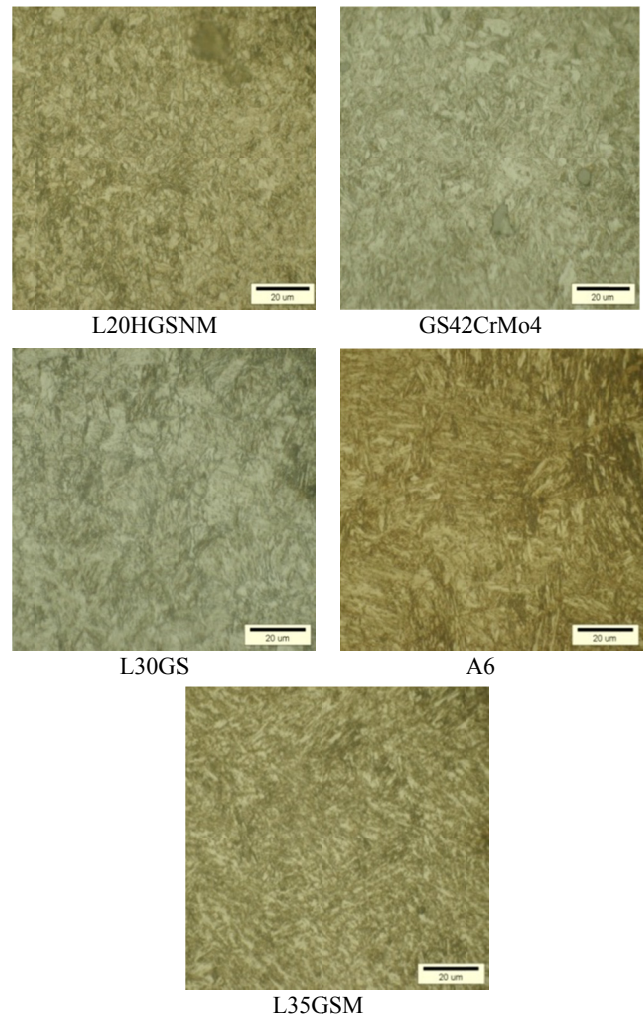
Fig. 13. The microstructure 2 mm under the surface of the tested cast steels

After the metallographic examinations had been carried out, it has been found for the analysed L20HGSNM, GS42CrMo4, A6, L30GS and L35GSM cast steels that in their surface layer there occurred tempered martensite formed as a result of the surface hardening process. In the core of the chain wheels, there was found fine-grained sorbite formed as a result of normalization as well as quenching and tempering of the casts. Non-metallic inclusions were observed in the structure of the casts (sample views of the inclusions are shown in Fig. 14). They were located mainly in the areas of contact between the sand mould and the molten metal.

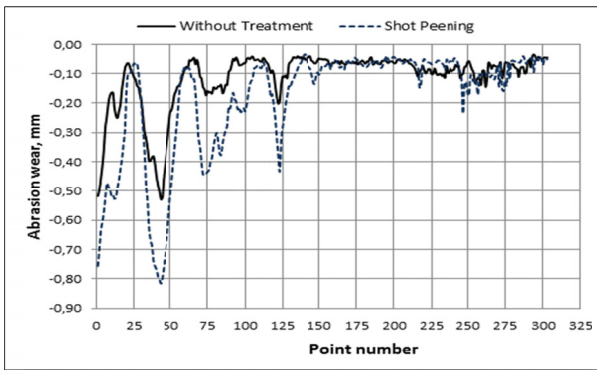
Fig. 15. Graphs of the value of averaged wear of the  $i$ -th point of the measuring route  $\delta_{i\_AVG}$  determined for the shot-peened and not shot-peened variants of the chain wheel made of the L35GSM cast steel

Fig. 15 shows examples of graphs of the value of averaged wear of the  $i$ -th point of the measuring route  $\delta_{i\_AVG}$  for the shot-peened and not shot-peened variants of the chain wheel made of the 35GSM cast steel, while Fig. 15 presents histograms of this parameter. Based on Table 4, Fig. 14 and Fig. 15, an increase in the wear of the chain wheels subjected earlier to shot peening can easily be noticed. The increased wear may result from deformations and cracks of the surface caused by the dynamic action of the shot (Fig. 5), which facilitate cutting of the material by the grains of quartz sand.

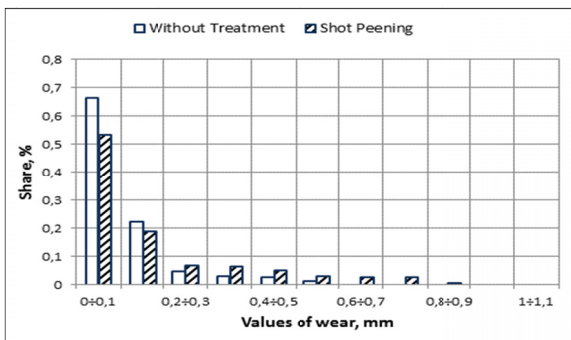
Fig. 16. Histograms of the value of averaged wear of the  $i$ -th point of the measuring route  $\delta_{i\_AVG}$  determined for the shot-peened and not shot-peened variants of the chain wheel made of the 35GSM cast steel

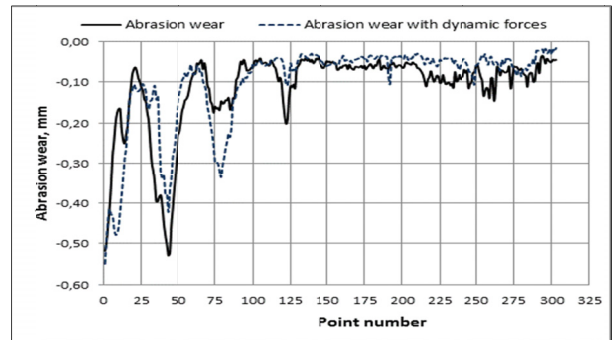
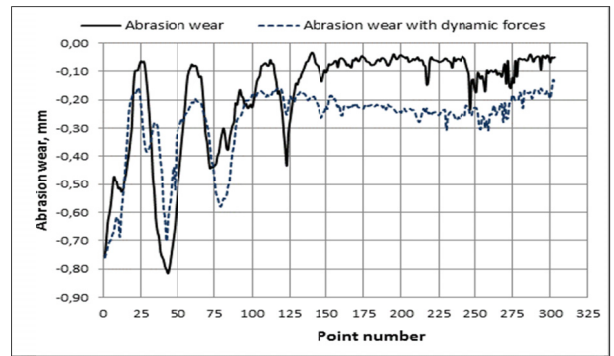
Fig. 17. Graphs of the value of averaged wear of the  $i$ -th point of the measuring route  $\delta_{i\_AVG}$  determined for the chain wheel made of the L35GSM cast steel, A – wheels not subjected to shot peening, B – wheels subjected to shot peening

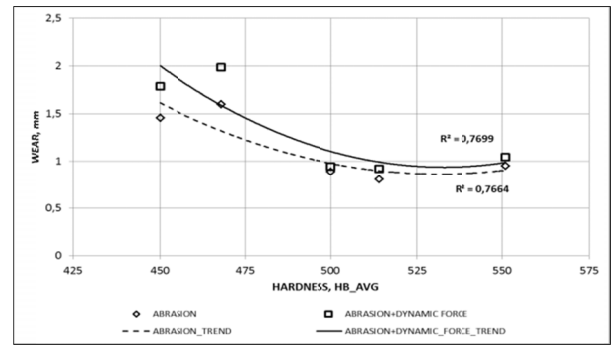
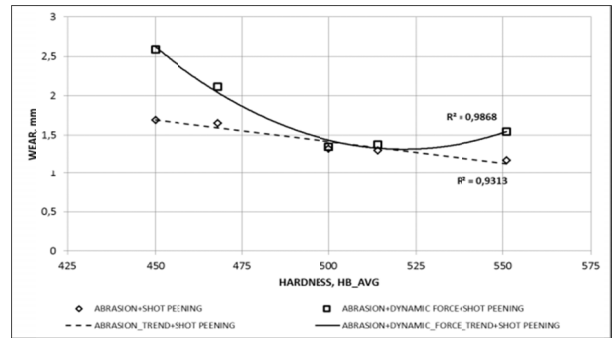
Fig. 18. The impact of an additional dynamic force on the abrasive wear the chain wheels tested as a function of the average surface hardness  $HB_{AVG}$ , A – wheels not subjected to shot peening, B – wheels subjected to shot peening

jected to shot peening as a function of the average hardness of the surface, which are presented on Fig. 18A.

An additional dynamic force has a significant impact on the abrasive wear in the case of the A6 and L30GS manganese cast steels. When analysing Fig. 18, there can be noticed a differentiation in the values of the abrasive wear as a function of the average surface hardness depending on the fact whether the wheels were subjected to shot peening or not.

For the non-shot peened variant, the graphs of the wear of the chain wheels, both in the case of their operation with an additional dynamic force and without it (Fig. 18A) have the same non-linear character. The chain wheels operated without the presence of a dynamic force were characterized by greater resistance to wear. Assuming the synergistic component  $\Delta V_{DYN}$ , determined from the equation (2), as a measure of the impact of the dynamic force on the wear, in percentage terms this component ranged from 10 to 25% (Fig. 19).

The graphs of the wear of shot-peened chain wheels as a function of the average surface hardness of the materials tested differ significantly from each other in the cases of the operation with an additional dynamic force and without it (Fig. 18B). The graph obtained in the conditions of the destructive action in presence of the abrasive only is linear, while the graph for the case of the combined action of the abrasive and a dynamic force has a parabolic shape with a distinct minimum at the hardness of 500 HB. The differentiation in the value of the synergistic component  $\Delta V_{DYN}$  is significantly higher in comparison with the wheels not subjected to shot peening, as it ranges from 2 to 52% (Fig. 19).

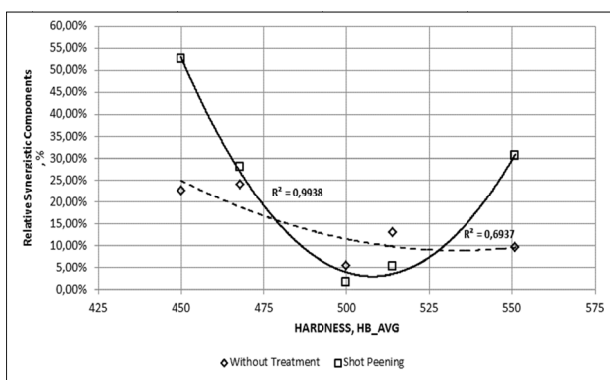
Fig. 19. The values of the synergistic component  $\Delta V_{DYN}$  as a function of the average surface hardness of the materials tested

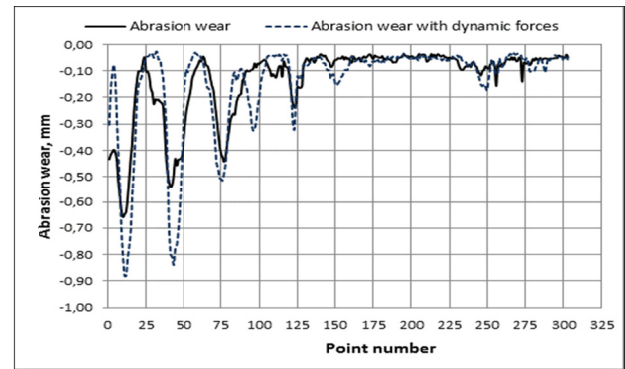
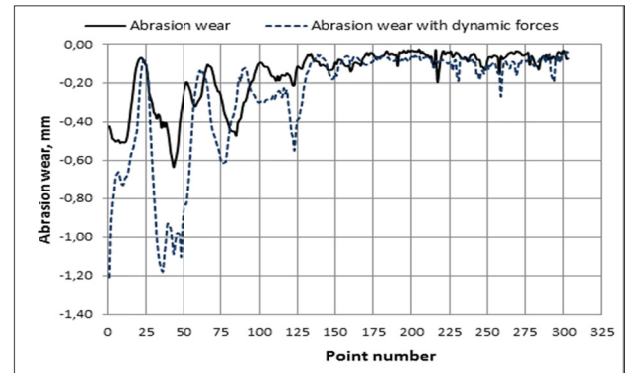
Fig. 20. Graphs of the value of averaged wear of the  $i$ -th point of the measuring route  $\delta_{i\_AVG}$  determined for the chain wheel made of the GS42CrMo-4 cast steel, A – wheels not subjected to shot peening, B – wheels subjected to shot peening

In the case of the GS42CrMo4 cast steel subjected to shot peening, the impact of the dynamic force resulted in greater increases in the wear as compared with cast steels of similar hardness, such as L35GSM and L20HGSM. Fig. 20 shows a comparison of the values of the averaged wear  $\delta_{i\_AVG}$  obtained at the presence of a dynamic force and without it for both surface preparation variants of the GS42CrMo4 cast steel. The presence of the dynamic force for both variants of chain wheels resulted in an increased wear, but for the shot-peened variant this increase was significantly greater (Fig. 20B).

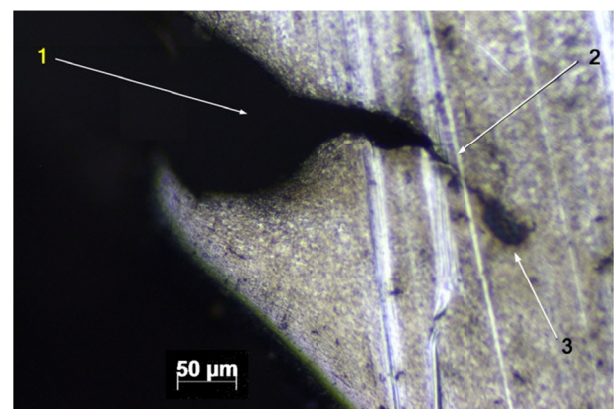
Fig. 21. Microstructure of the GS42CrMo4 cast steel; 1 – microcut, 2 – crack, 3 – non-metallic inclusions

When analysing the microstructure of the surface layer of the GS42CrMo4 cast steel operated in the presence of the abrasive only (Fig. 21), many oblique microcuts were observed.

Cracks were propagated from their vertexes down into the surface layer and in many cases they reached the place where non-metallic inclusions were located. It can be supposed that the resulting cavity with an additional crack is conducive to further cracking of this fragment and enlarging of the damage to the surface. The case shown in Fig. 21 is typical of the materials susceptible to brittle cracking [13].
