P. RANACHOWSKI*, Z. RANACHOWSKI*#, K. WIECZOREK**,
M. JAROSZEWSKI**, S. KUDELA JR***

STUDY OF MODIFIED ALUMINOUS PORCELAIN SUBJECTED TO MECHANOACOUSTIC TESTS

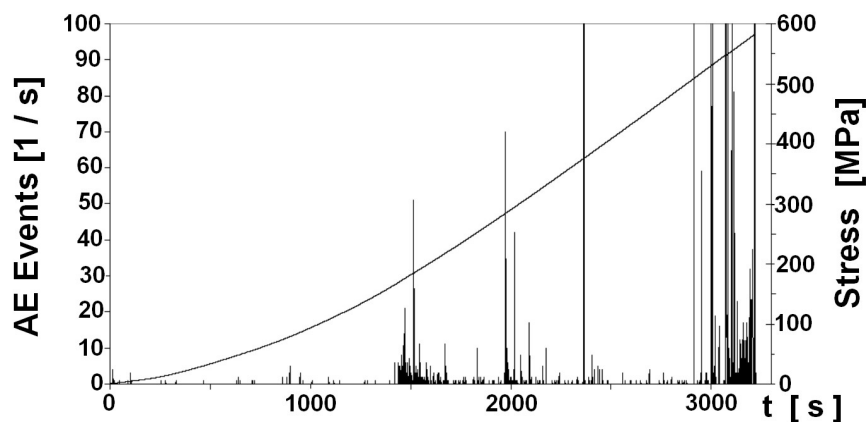
Fig. 2 Mechanoacoustic characteristics of the weaker specimen of the investigated material whose strength was equal to 582 MPa

Mechanoacoustic characteristics recorded for the specimens of the investigated material demonstrated a marked diversification. It is, however, typical of all ceramic aluminosilicate materials and is connected with a large spread of their compressive strength. The nature of degradation effects recorded for the investigated material is similar as in the reference material and consists of three well-defined stages: preliminary, subcritical and critical [6,7]. Microscopic examination of the effects of compressive stress was carried out on the specimens in which the application of compression was stopped at selected values: 275 MPa – after preliminary degradation, 504 and 582 MPa – in advanced subcritical stage and 690 MPa – where bigger fragments of the destroyed sample were examined (critical stage). Selected mechanoacoustic characteristics of the investigated material samples are presented in Figs. 2,3.

the diversified strength of the material samples, the scope of development of subcritical effects was different for individual specimens – Figures 2 and 3. The recorded EA signals showed very varied intensity during the subcritical stage. However, weaker signals dominated and occurred individually or less frequently – Figure 2 – in longer ranges of continuous activity.

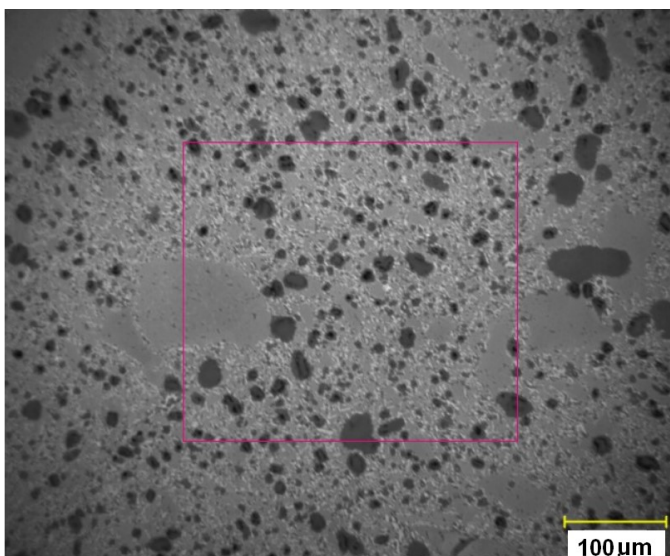
Fig. 4. Image of the tested material after the preliminary stage of degradation, $\times 200$. The sample was loaded to 275 MPa. There are visible dark areas of crushed out cullet particles, quartz grains and to a small extent – fragments of mullite precipitates. They constitute about 10% of the surface area

Elements of the microstructure, destroyed and crushed out from the surface of the test specimens at the end of the preliminary stage, accounted for about 10% – Figure 4. This applied to almost all cullet particles, a large majority of quartz grains and few fragments of mullite precipitates. In the case of the reference material, the number of crushed out fragments was clearly lower, and the degradation of the mullite precipitates in the preliminary stage was hardly seen. The reference porcelain, presented in detail in [6], showed better homogeneity and also the cohesion of the microstructure, resulting from a stronger connection of the material building phases.

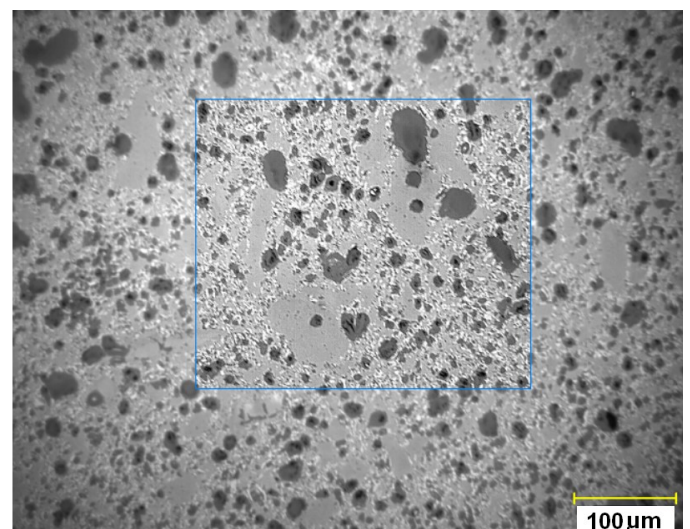
Fig. 5. Image of the microstructure of the central part of the tested sample loaded up to 504 MPa, $\times 200$. There are visible smaller dark areas after crushed out particles of cullet and quartz, and larger – after fragments or even whole mullite precipitates. There are also numerous microcracks in the areas of concentration of small, bright corundum grains. Crushed out elements cover about 19% of the surface

For individual microscopic observation areas of samples loaded to an advanced subcritical level (504 and 582 MPa), crushed out elements of microstructure included quite a wide range – from 15% to even twenty-several percent, usually around 17%. Particularly many damaged elements were observed in the middle part of the samples – Figure 5. Figure 6 shows the size distribution of crushed out elements of microstructure in the samples of the tested material, which were loaded to 275, 504 and 582 MPa. Quantities of elements in the range of $5 \div 15 \mu\text{m}$ were definitely predominant, with the average value equal to $11 \mu\text{m}$. They came from particles of cullet and smaller grains of quartz or their fragments. Larger crushed out elements, in particular

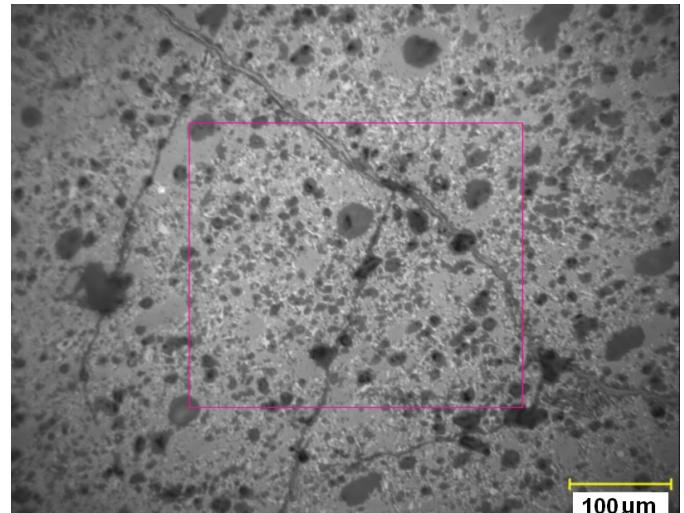
Fig. 7. The cracking system in the middle part of the sample of the tested material, subjected to destruction at 690 MPa, $\times 200$. There are numerous dark areas after crushed out elements of the microstructure – particles of cullet, quartz, mullite precipitates and corundum agglomerates. They constitute a total of 22% of the surface area

During the critical stage, further fragments or even whole precipitates of mullite as well as corundum agglomerates were damaged and crushed out, especially in the vicinity of the mullite phase. Therefore, the surface of damaged and broken elements of the microstructure increased to more than 20%, but with significant differences for individual microscopic observation areas. The most important and characteristic effect occurring during the critical stage was the formation and propagation of large, usually little branched cracks. Their development was facilitated by numerous damaged and separated from the matrix elements of the microstructure. Starting from loose fragments of cullet and quartz grains, through cracked mullite precipitates and finally – strongly fractured areas of corundum grains concentration. At sufficiently high stress, there took place a sudden increase of cracks and destruction of the entire specimen, which was accompanied by very strong but short-lasting acoustic activity. The effects of critical degradation of the microstructure of the tested material are presented in Figure 7.
