## FRACTOGRAPHY OF STRESS CORROSION CRACKING OF 20% COLD WORKED TYPE 304 H STAINLESS STEEL CONTAINING $\delta$ -FERRITE IN OXIDIZING PRIMARY WATER

Fractography of stress corrosion cracking (SCC) of 20% cold worked Type 304 H stainless steel containing  $\delta$ -ferrite was studied using a compact tension (CT) specimen in oxidizing primary water with a scanning electron microscope (SEM) and electron back scattered diffraction (EBSD). The stress corrosion crack propagated mostly in transgranular stress corrosion cracking (TGSCC) mode and sometimes in intergranular stress corrosion cracking (IGSCC) mode. TGSCC paths were along the  $\{111\}$  plane with both high resolved shear stress and high resolved tensile stress. IGSCC preferentially propagated along the grain boundary perpendicular to the loading axis. The findings in this work suggest that TGSCC proceeds through formation of a weakening zone at the head of the crack tip by interaction of slip and corrosion and then cracking of the weakened zone by tensile stress.

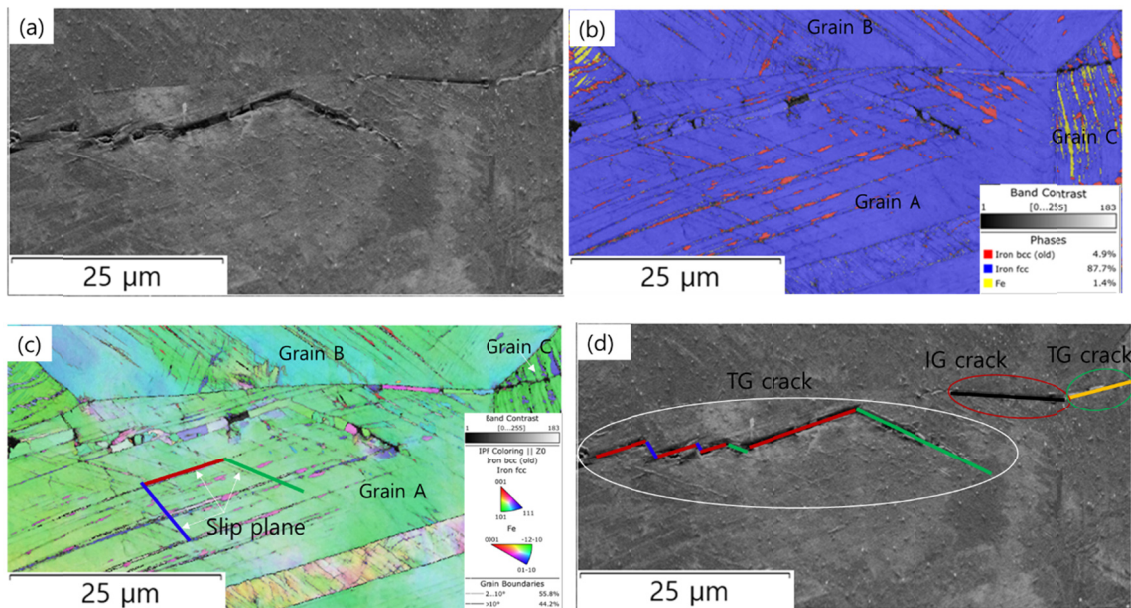
Fig. 2 shows the features around the crack tip at the side surface of the CT specimen, where (a) is the SEM image; (b) the phase with the band contrast image; (c) the inverse pole figure with the band contrast image with; and (d) duplication of (a) with superposition of the cracking path. The SCC crack in grain A of Fig. 2(a) propagates in a zigzag mode. Most of the deformation induced martensite is  $\alpha'$  martensites that are aligned along the slip plane as shown in grain A of Fig. 2(b) and  $\epsilon$  martensite in grain C of Fig. 2(b) is also aligned along the slip plane as  $\alpha'$  martensites. Slip lines are overall straight in a macroscale but slightly curved in a microscale, especially in grain C of Fig. 2(b) because of the 20% cold work. Slip lines parallel to the red line and green line in grain A of Fig. 2(c) are well distinguished by both the band

contrast image and the martensite formed on the slip lines. The slip line parallel to the blue line in grain A of Fig. 2(c) is also identified by a faint band contrast while deformation induced martensite on the slip line parallel to the blue line is not visible because the amount of deformation on the slip plane parallel blue line is less than the slip planes parallel to the red line or green line. The fourth slip plane of grain A in Fig. 2(c) was identified by a pole figure. The Pole figure of grain A shows that the fourth slip plane normal in grain A of Fig. 2(c) is almost perpendicular to the loading axis, so trace of slip line of the fourth slip plane is implicit in Fig. 2(c) because the resolved shear stress on the fourth slip plane is almost zero. In the FCC crystal structure, there are four slip planes and three slip directions on each slip plane and therefore 12 slip systems. Slip planes can be identified from the band contrast image but slip directions can not be identified from that. The amount of deformation on the slip plane is proportional to the Schmid factor. By comparing Figs. 2(a), (b) and (c), the cracking mode was marked in Fig. 2(d), where cracks in both the white elliptical circle in grain A and the green elliptical circle in grain C propagated in the transgranular mode while the crack in the red elliptical circle between grain A and grain B propagated in the intergranular mode. Cracks marked with the same color in the white elliptical circle are in the same  $\{111\}$  plane in Fig. 2(d). The crack in the white elliptical circle seems to have the strongest tendency to propagate along the red  $\{111\}$  plane and then along the green  $\{111\}$  plane and least along the blue  $\{111\}$  plane. The crack along the fourth slip plane in Fig. 2(c) was not observed because there was no slip on that plane and very low tensile stress on that plane.

Fig. 2. Enlarged view of the crack tip at the side surface: (a) SEM image, (b) Phase with band contrast, (c) Inverse pole figure with band contrast and (d) Superposition of the cracking path on the SEM image of (a)

Fractography near the SC crack tip (Fig. 3) shows that the crack propagated mostly in the TGSCC mode. The cracking planes marked A, B and C appear to be parallel to each other and the interfaces between two cracking planes are straight, suggesting that TGSCC has crystallographic features. By comparing Fig. 2(d)

and Fig. 3, we can surmise that the red and blue lines in Fig. 3 correspond to those in Fig. 2(d). Therefore, the cracking planes A, B, C in Fig. 3 may be on the  $\{111\}$  plane. The step between two cracking planes marked by the blue line in Fig. 3 may be another  $\{111\}$ . The boundary between the red and blue lines is a river line.
