M. S. MILLMAN*, P. NYSSSEN**, C. MATHY**, D. TOLAZZI***, L. LONDERO***, C. CANDUSSO***,
J. C. BAUMERT ****, M. BRIMMEYER*****, D. GUALTIERI*****, D. RIGONI*****

DIRECT OBSERVATION OF THE MELTING PROCESS IN AN EAF WITH A CLOSED SLAG DOOR

Keywords: Electric Furnace, Process control, Camera, Scrap Melting

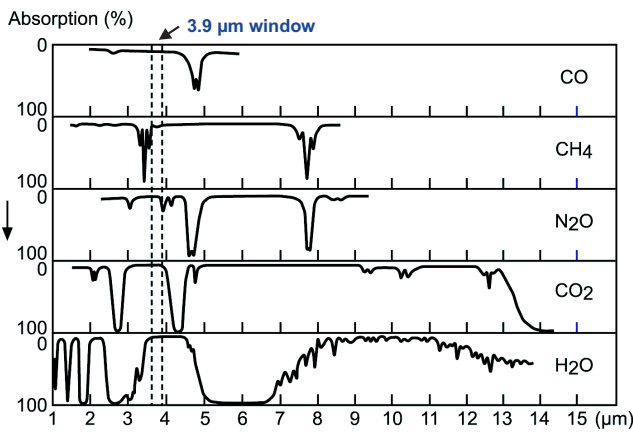
In addition to dust, the EAF process also generates flames which are composed of a variety of combustion gases that each absorbs light to varying degrees and at different wavelengths. Therefore, it is not possible to see through a flame, using a camera system that operates for example, under white light. However, Figure 1 shows that there is a unique operating window, at a mid-infrared wavelength of 3.9 μm , where light is not absorbed by any of the individually combined combustion gases and is therefore unaffected by flame.

Fig. 1. Spectral Absorption of Combustion Gases

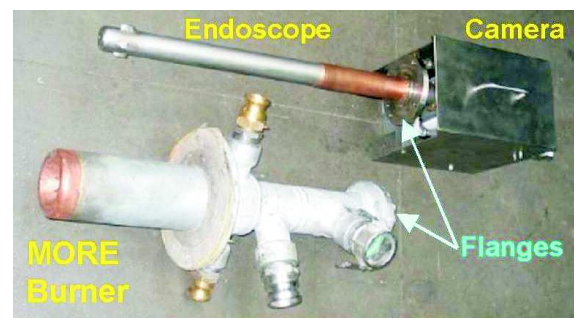
Fig. 4. View of the Complete Visualisation System and MORE Burner

Figure 4 illustrates the resulting visualisation system ready to be fitted inside the MORE burner. A fast-disconnect flange connects the camera to the burner body.

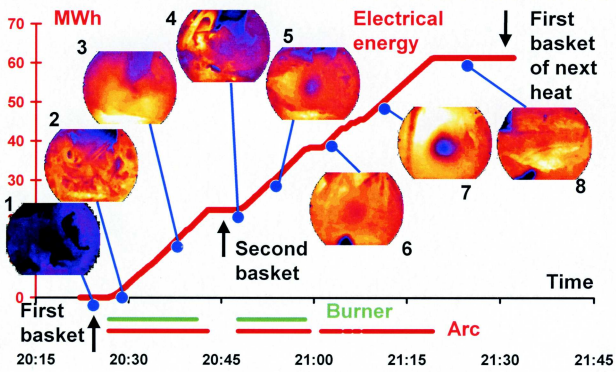
An analysis of the recorded images has been carried out to link the image information to processing events. Figure 9 gives an example of a two scrap-basket heat: the red line indicates the change in electrical energy consumption and the preheating and burner/ arcing operations are highlighted.

Fig. 9. Melting Progress Through the Heat (ArcelorMittal Esch-Belval)

Several images have been selected during the process:

- (1) : At first scrap basket charge, a low temperature profile is observed.
- (2) : At arc and burner on, scrap melting starts and cold scrap is visible.
- (3) : As the scrap melting cavity grows, the steel bath is seen.
- (4) : After second basket charge, arc and burner re-start; scrap melting progresses; the average temperature is higher compared with the first basket.
- (5) : The scrap melting cavity is maximised.
- (6) : Slag foaming begins.
- (7) : No more scrap is observed; the arc is heating on flat bath.
- (8) : The tapping operation; no skull is seen on the furnace walls.

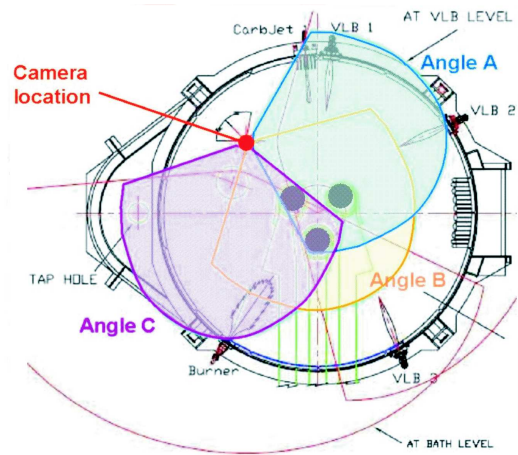
The camera system was also installed in the roof of Corus Engineering Steel’s ‘N’ furnace. The camera system was positioned in the furnace roof between the additions chute and the exhaust gas hot-offtake and pointed towards Burner Module 3 into the 2 o’clock region relative to the taphole, as illustrated in Figure 10 (Angle A).

Fig. 10. Location of the Camera/ Endoscope Unit in the Roof of the Aldwarke N’ Furnace (Plan View)

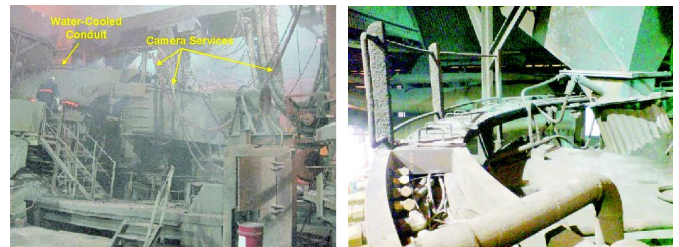
The water-cooled camera and endoscope unit was held in a water-cooled air-blower shroud. The camera-system services were protected from heat and dust by placing them into a dedicated water-cooled channel that was built around the rim of the furnace roof as shown in Figure 11.

Fig. 11. Water-Cooled Channel Containing the Camera Services (Aldwarke ‘N’Furnace)
