M. ROZMUS-GÓRNIKOWSKA\*, J. KUSIŃSKI\*, M. Blicharski\*

## THE INFLUENCE OF THE LASER TREATMENT ON MICROSTRUCTURE OF THE SURFACE LAYER OF AN X5CrNi18-10 AUSTENITIC STAINLESS STEEL

The influence of laser shock processing (LSP) on microstructure of the surface layer of an X5CrNi18-10 austenitic stainless steel was studied. The laser treatment was performed using a Q switched Nd:YAG ReNOVAL laser.

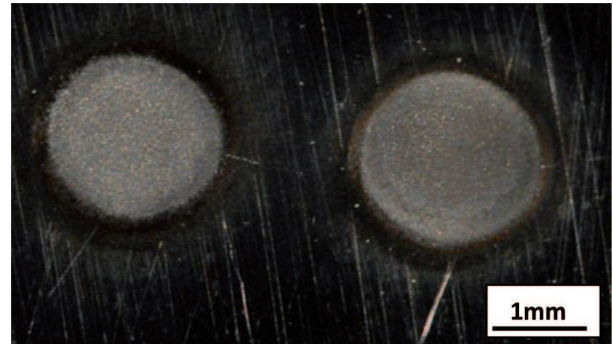
Fig. 2. A view of the surface of treated material after laser treatment
