K. ŻABA\*

## WEAR RESISTANCE OF ALUMINIZED STEEL PLATES

The results of the abrasion resistance measurements of aluminized steel strips are presented in the hereby paper. Steel strips of DX52D+AS120 grade, before and after a heat treatment at temperatures of 200-1000°C for 1 – 5760 minutes, were tested. Tests of the abrasion resistance were carried on in a specially built device: rotating disk – sample performing a plane-rotary motion, with an application of a lubricating medium. Examinations of the abrasion resistance were also performed by means of the block-on-ring tester. Estimations of a coating mass loss, roughness and thickness changes were carried on. The obtained results are illustrated by diagrams and macro- and micro-observations. Phase analysis investigations were also performed on samples selected after the abrasibility testing. The range of the heat treatment parameters – after which the Al-Si coating increased its abrasion resistance – was estimated.

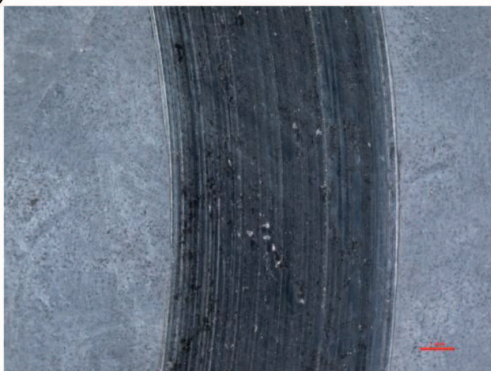
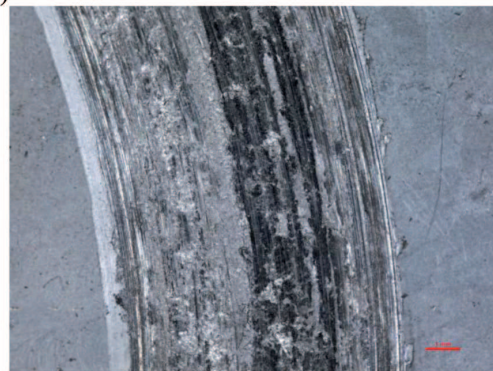
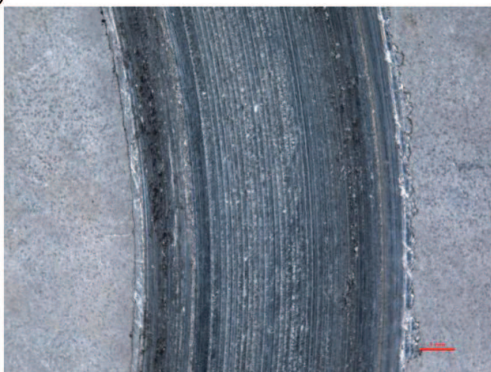
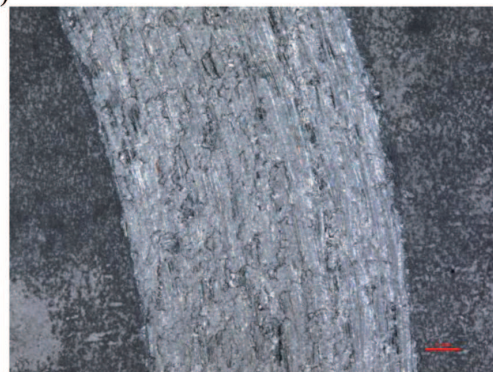
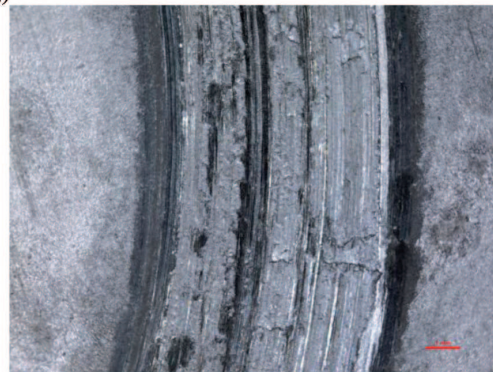
At the coating observation, apart from the abrasion zones, changes in the coating appearance from bright and glossy (Fig. 3a-d) to partially (Fig. 3e-h, j, l) or completely dark and matt (Fig. 3i, k, m-o) attract attention. The results of observations of the coating surface – after an abrasion - are highly correlated with the coating appearance.

Fig. 3. The observation results of the selected coating surfaces after the heat treatment and abrasibility tests  
 a) Initial state, b) 200°C-180min., c) 200°C-5760min., d) 500°C-180min., e) 500°C-1440min., f) 600°C-5min., g) 600°C-30min.,  
 h) 700°C-5min., i) 700°C-10min., j) 800°C-2min., k) 800°C-5min., l) 900°C-1min., m) 900°C-5min., n) 1000°C-2min., o) 1000°C-5min

During an abrasive wear of a relatively soft material the mechanisms of grooving and microcutting are dominating and mutually competing. Gradual passing from one wear mechanism to another was occurs and in consequence grooving and microcutting of various proportions coexist in a wide range (Fig. 3a-d). Such influence is accompanied by a minimal or small coating mass loss, presented in Fig. 4.

A characteristic adhesive wear occurs in the samples, which surface became dark and matt under the heat treatment influence. Hard, but very brittle, particles present on the coating surface are torn off during an abrasion process. A continuation of the abrasion process intensifies the adhesive sticking, sinking of particles deep inside the coating, mixing with it and in consequence the coating fragments are tearing off and craters are formed (Fig. 3i, k, m-n). These tribologic effects cause an uneven, deep wearing out of a material, which is proofed by the mass loss results. The coating surface roughness results, which reflect the surface unevenness after abrasion, are shown in Fig. 5-6. Examinations are accompanied by acoustic effects intensifying with progressing tests, giving evidence to a high and constantly increasing friction coefficient. When the coating surface after the abrasibility tests is in certain areas dark and in other bright it means, that two or even three mechanisms of wear are simultaneously occurring: adhesive in darker places while microcutting and grooving in brighter ones (Fig. 3e-h, j, l).

ture of 1000°C for 5 minutes (Fig. 3o). None of the previously identified wearing mechanisms occurs during the abrasion. The coating surface becomes smooth, micro-unevenness is removed, no scratching or craters are seen and none acoustic effects are heard – during the tests. On the other hand, the counter sample surface (Hardox 500 steel) undergoes some wearing in contact with the coating. This indicates the complete change of the coating hardness after the heat treatment. Surface and structural changes of the coating are confirmed by mass loss tests, roughness, friction depth and force.

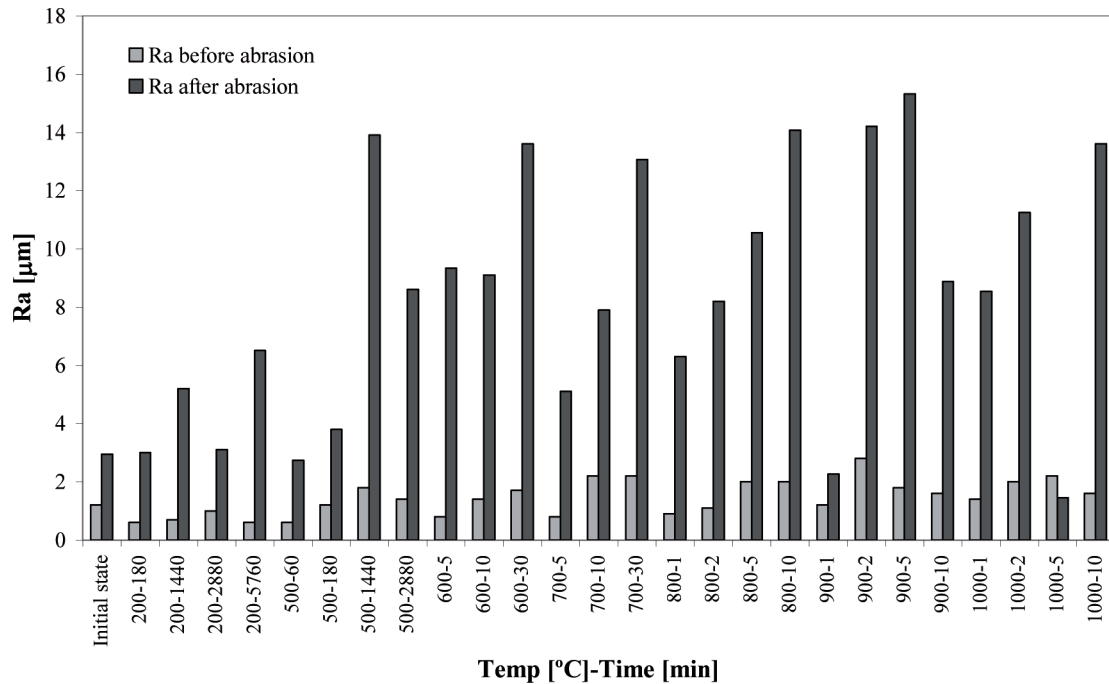
Fig. 5. Medium  $R_a$  values of coating surface roughness before and after the abrasion depending on heat treatment parameters

For the majority of samples after the heat treatment and abrasion the results indicate the increased roughness – from several dozen to a few hundred percent in relation with the after heating value - determined by  $R_a$  and  $R_z$  parameters. The highest  $R_a$  and  $R_z$  values are in the samples of the coating surface being completely dark and matt. The coating surface smoothing occurs in the

The results of coating surface roughness before and after the abrasion are presented in Fig. 5-6.

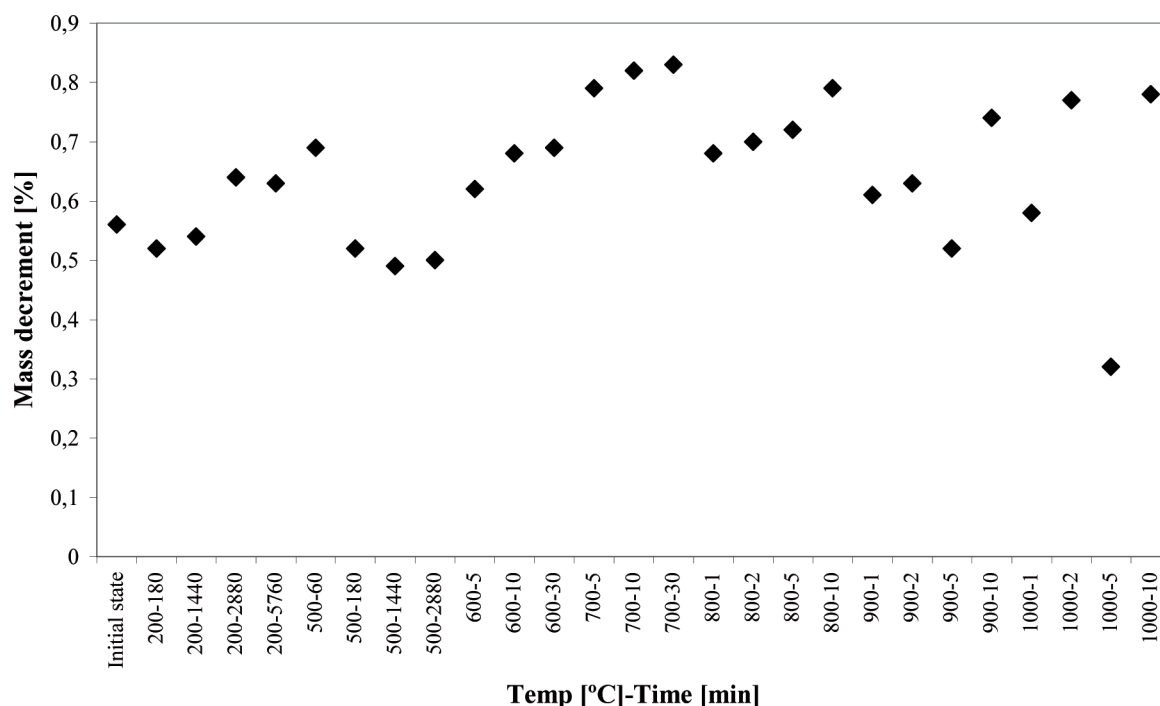
Fig. 8. Mass loss of samples – after the tribological tests – in dependence of the heat treatment parameters

For samples without the heat treatment and with the heat treatment which does not change the coating appearance, the mass loss – after the tribological test – equals 0.5-0.6%, (among others for samples heated at

temperatures of 200 and 500°C). A partial change in the appearance, exhibiting itself as darker areas, causes a slightly larger mass loss being app. 0.6-0.7% (for samples after the heat treatment at 600°C - 10 and 30

minutes, 800°C - 1, 2 and 5 minutes, 900°C - 1 and 2 minutes, 1000°C - 1 minute). An increase of a temperature and time of the heat treatment, changing the coating surface from bright into dark and matt, causes in the majority of cases the mass loss increase by app. 0.8%, (among others for samples exposed to 700°C - 10 and 30 minutes, 800°C - 10 minutes, 900°C - 10 minutes and 1000°C - 2 and 10 minutes). However the smallest mass loss equal only app. 0.3% occurs for the sample heat treated at 1000°C for 5 minutes, regardless that the coating is completely dark. This result confirms structural changes occurring in the coating heat treated under these conditions, transforming the coating from soft and plastic into hard and abrasion resistant.
